15 March 2017

McCloy Group
Suite 1, Level 3, 426 King Street
NEWCASTLE WEST NSW 2309

**RE: PROPOSED SUBDIVISION – BILLY'S LOOKOUT – STAGE 8
FISHERMANS DRIVE, TERALBA
SITE CLASSIFICATION (LOTS 801 TO 837)**

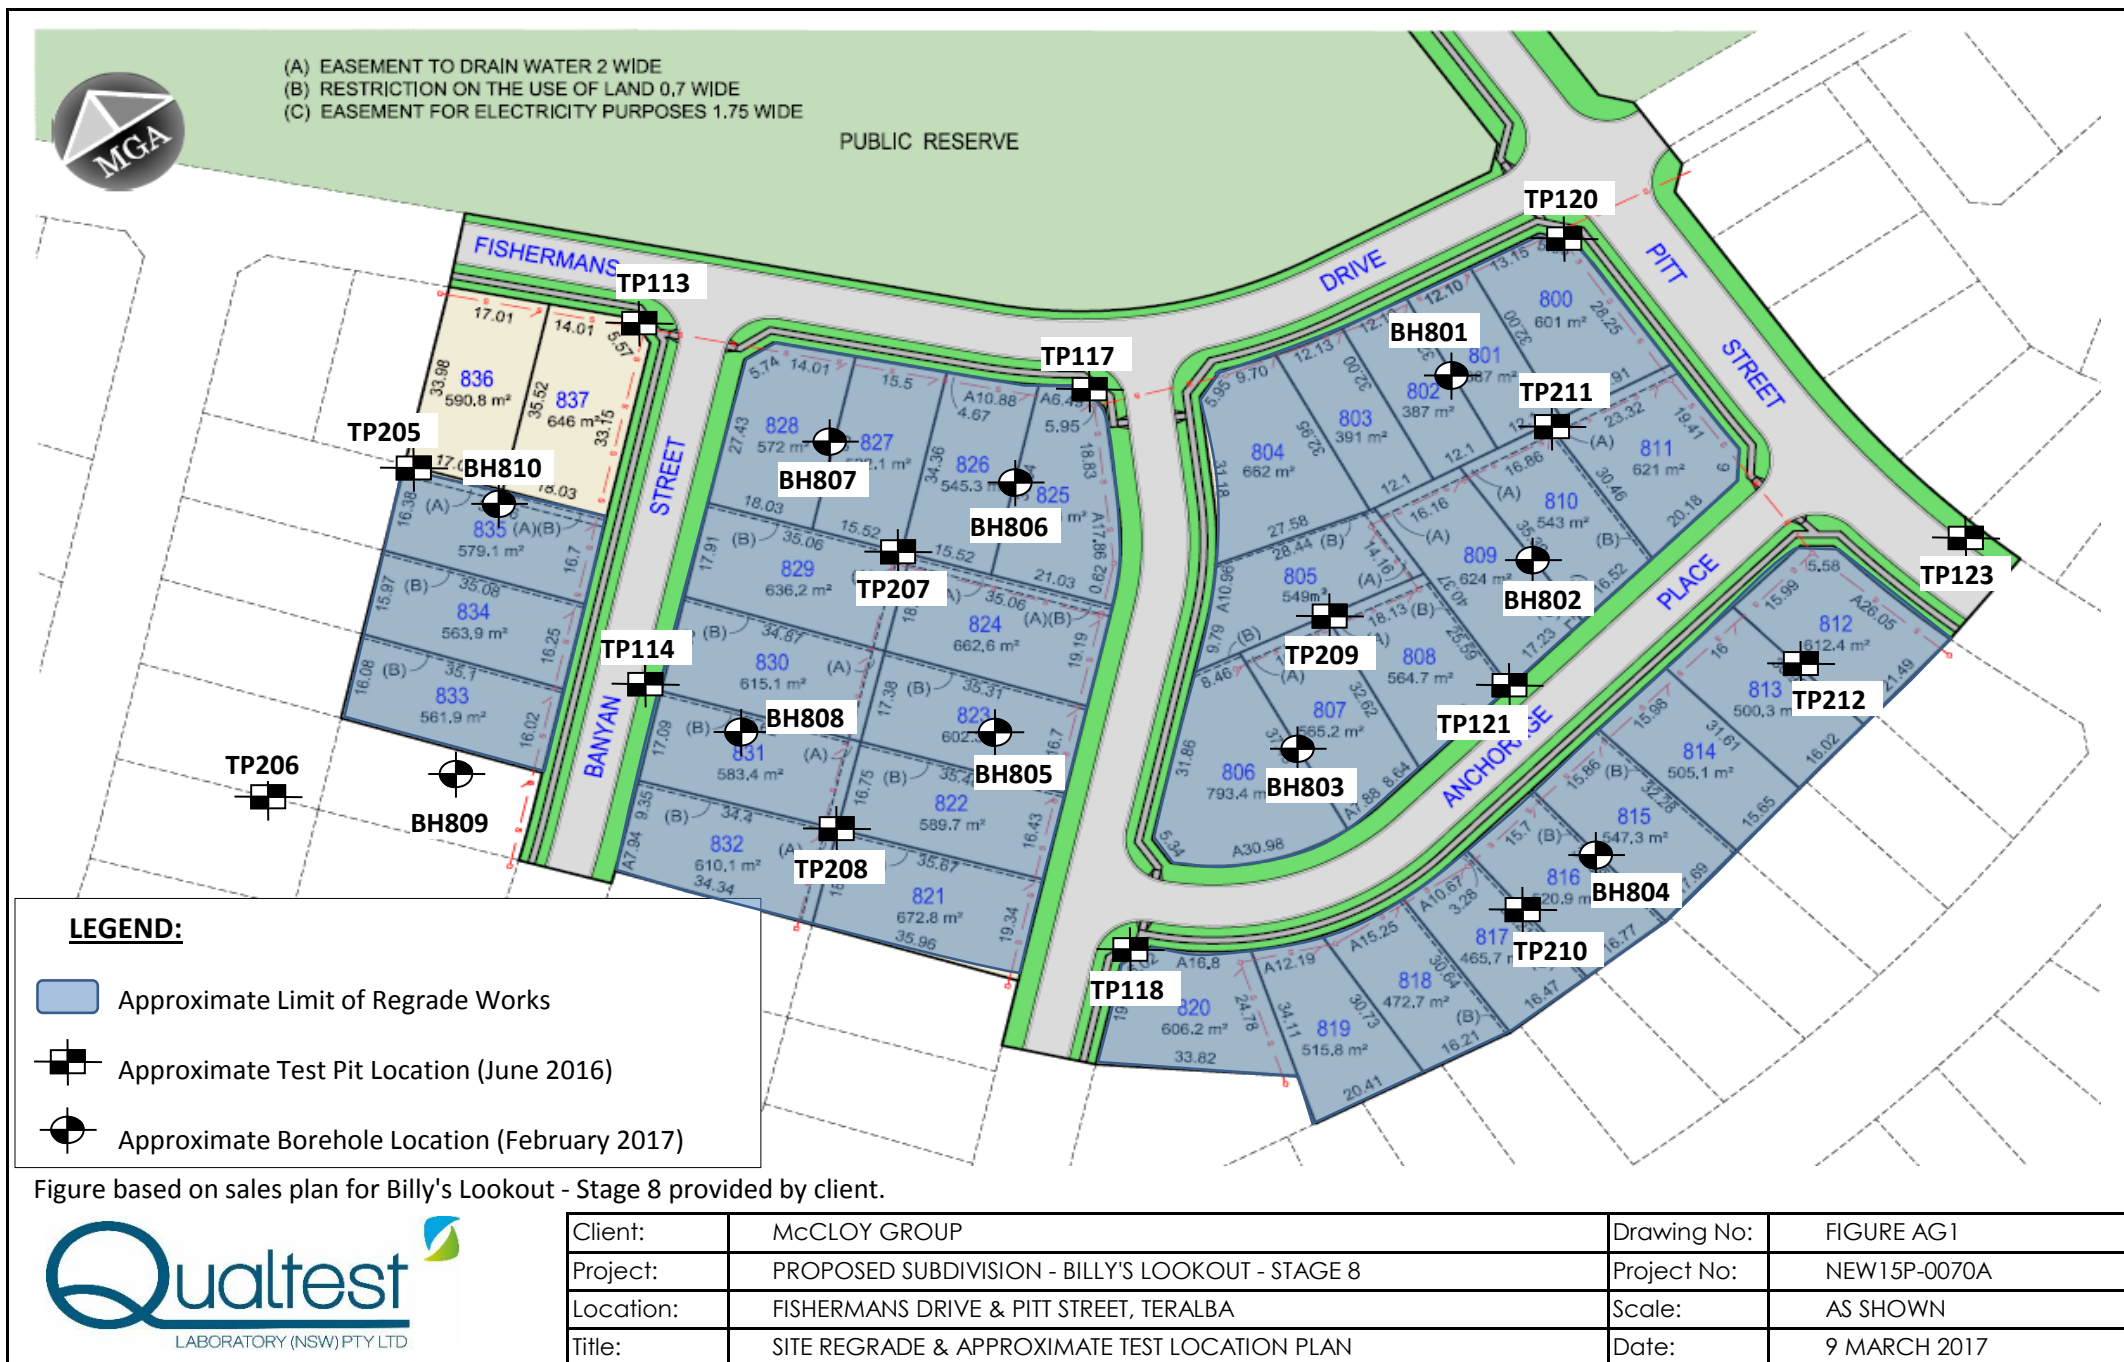
Approximate borehole locations are shown on the attached Figure AG1, which also includes test pit locations from the previous investigations conducted on site.

Site re-grading works were conducted on lots 800 to 835 (as shown on Figure AG1), between the dates of 29 June 2016 and 10 October 2016.
