Proposed Subdivision
Billy's Lookout - Stage 7
Site Classification

Fishermans Drive, Teralba

NEW15P-0070A-AK
27 March 2018

**RE: PROPOSED SUBDIVISION – BILLY'S LOOKOUT – STAGE 7
FISHERMANS DRIVE, TERALBA
SITE CLASSIFICATION (LOTS 701 TO 730)**

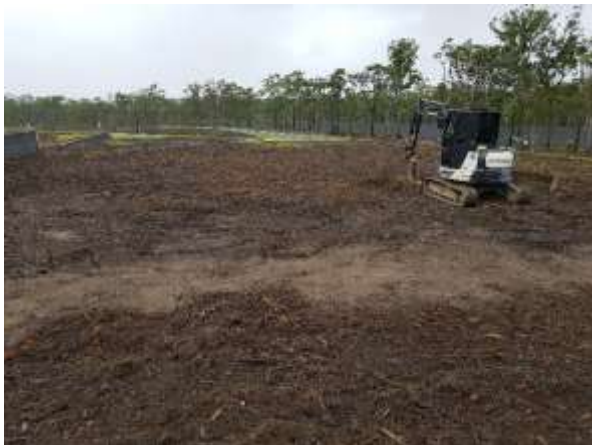
Photograph 1: Facing south from near northern corner of Lot 705, Excavator at TP702.

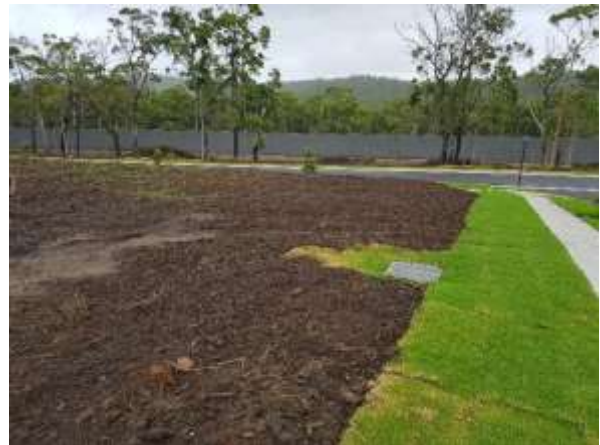
Photograph 2: Facing southwest from near northern corner of Lot 705.

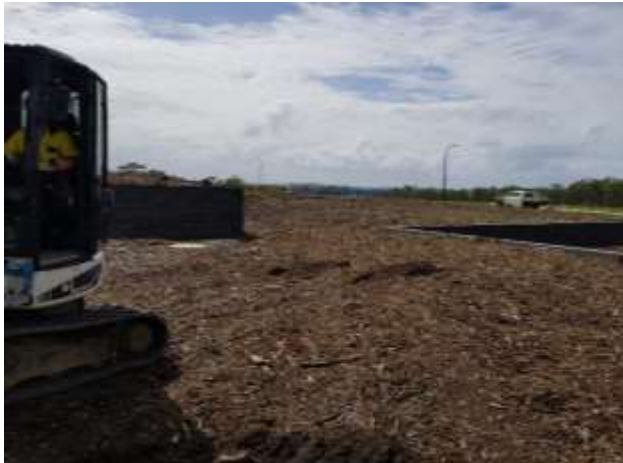
Photograph 3: Facing east from near TP706, Wheelhouse Road visible in background.

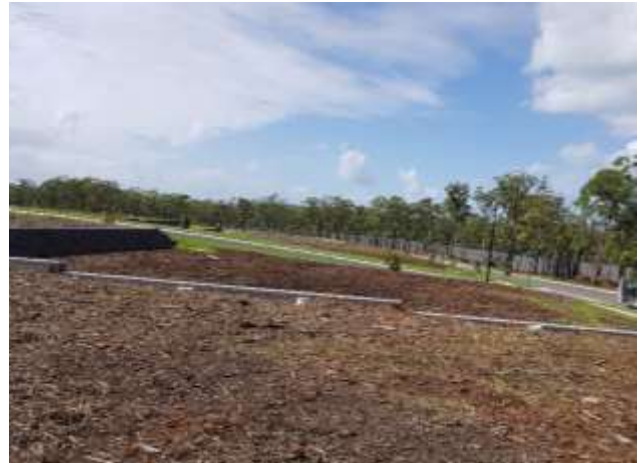
Photograph 4: Facing southeast from near TP706 (from Lot 729).

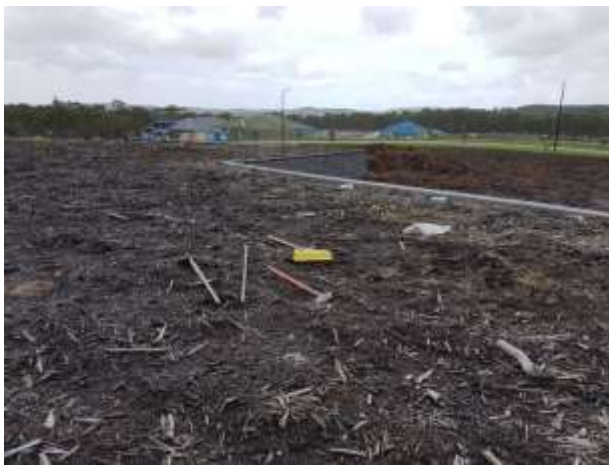
Photograph 5: Facing east from Lot 706.

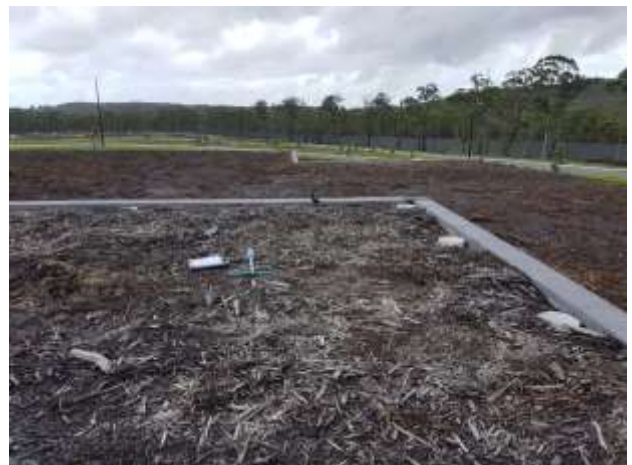
Photograph 6: Facing southeast from Lot 706.
