Billy's Lookout - Stage 11 Geotechnical Assessment

Fishermans Drive & Pitt Street,
Teralba

NEW15P-0070B-AI
29 November 2018

**RE: RESIDENTIAL SUBDIVISION – BILLY'S LOOKOUT – STAGE 11
FISHERMANS DRIVE & PITT STREET, TERALBA
SITE CLASSIFICATION (LOTS 1101 TO 1117)**

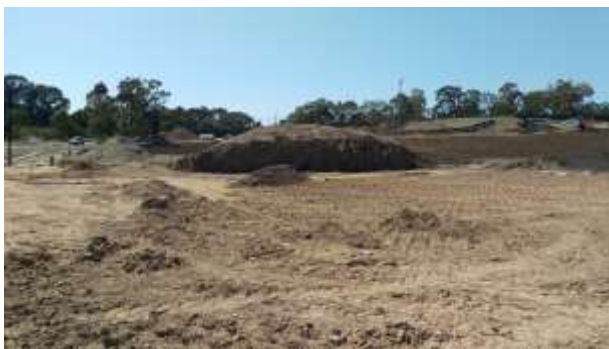
Photograph 1: From near northern corner of Lot 1101, facing southeast.

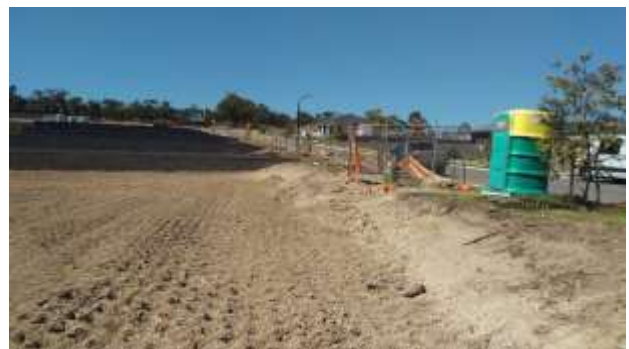
Photograph 2: From near northern corner of Lot 1101, facing southwest.

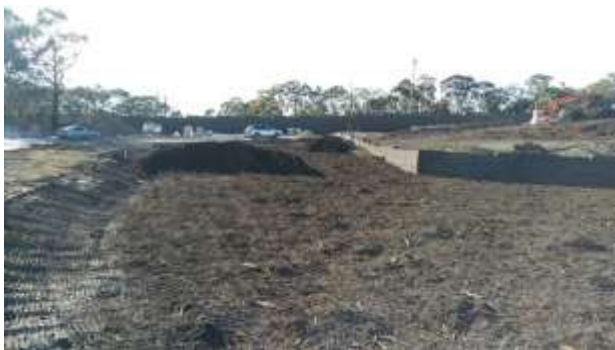
Photograph 3: From near north boundary of Lot 1114, facing southeast.

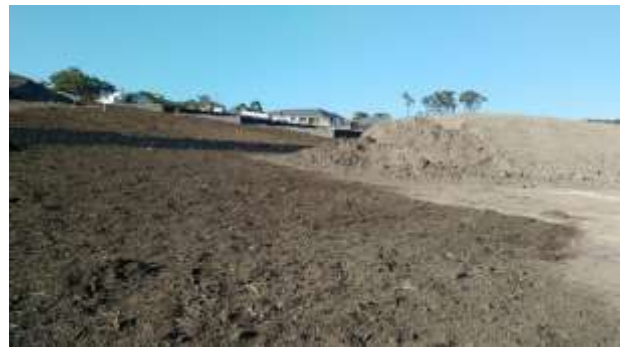
Photograph 4: From near north boundary of Lot 1114, facing south.

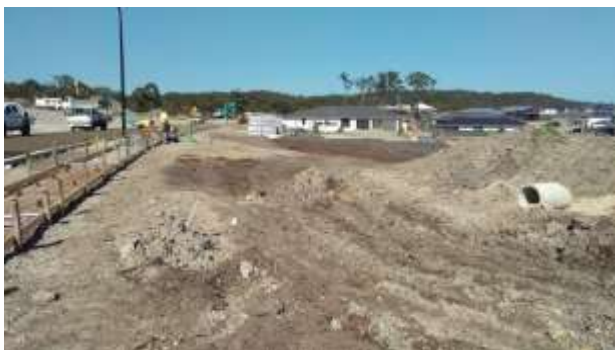
Photograph 5: From near southern boundary of Lot 1109, facing west.

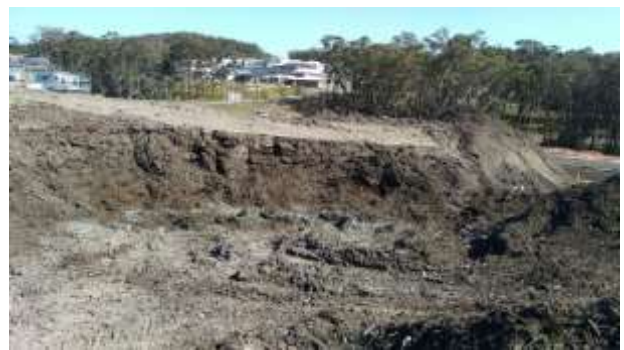
Photograph 6: From near southern boundary of Lot 1109, facing north.

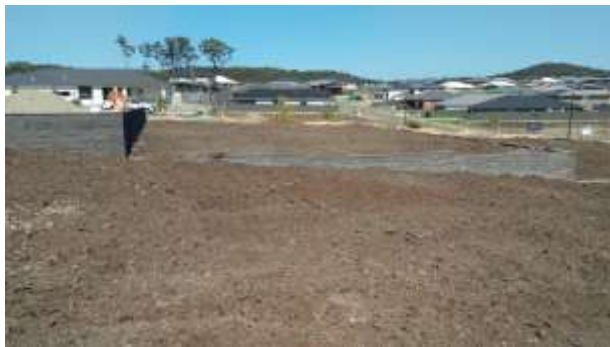
Photograph 7: From near southern boundary of Lot 1117, facing west.

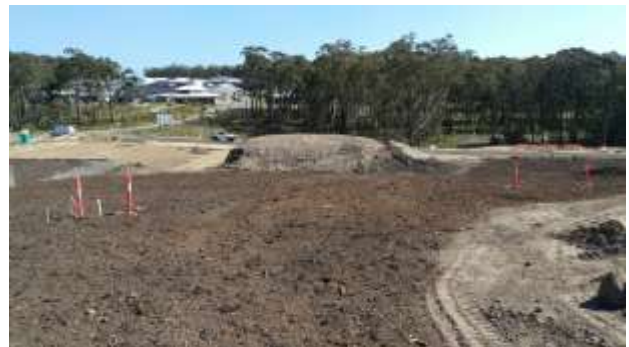
Photograph 8: From near southern boundary of Lot 1117, facing north.
