Residential Subdivision
Billy's Lookout -
Stage 22
Site Classification

Fishermans Drive,
Teralba

NEW15P-0070E-AB
21 February 2019

**RE: RESIDENTIAL SUBDIVISION – BILLY'S LOOKOUT – STAGE 22
FISHERMANS DRIVE, TERALBA
SITE CLASSIFICATION (LOTS 2201 TO 2219)**

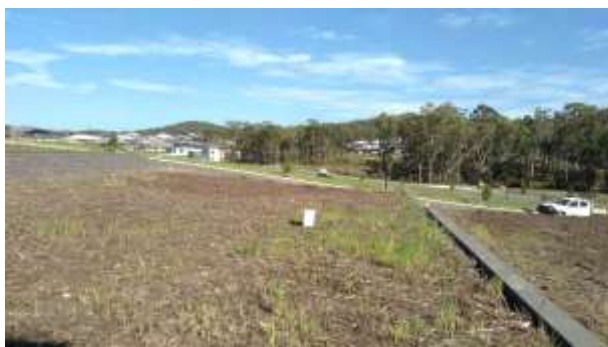
Photograph 1: From southeast corner of Lot 2203, facing northwest.

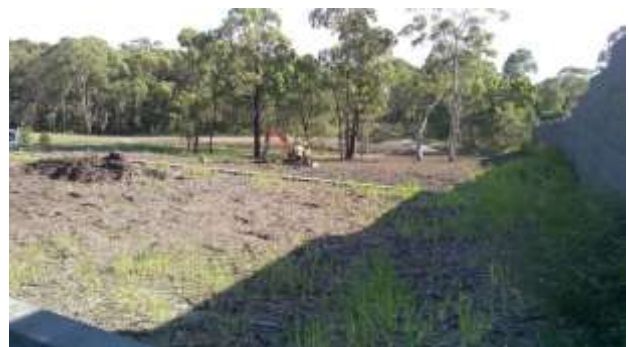
Photograph 2: From southeast corner of Lot 2203, facing northeast.

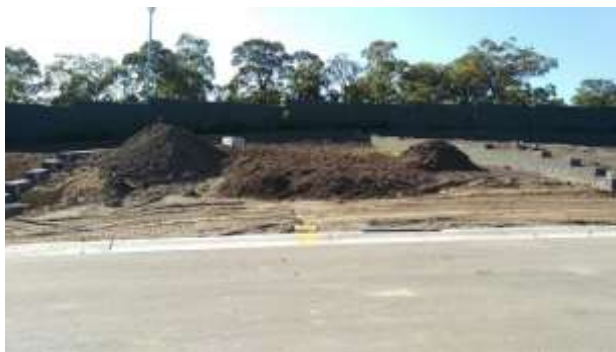
Photograph 3: From Fishermans Drive near Lot 2205, facing southeast.

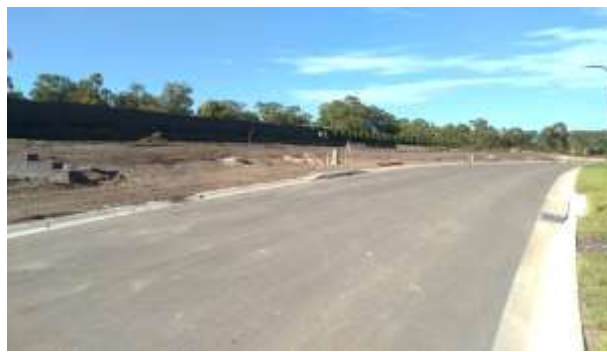
Photograph 4: From Fishermans Drive near Lot 2205, facing southwest.

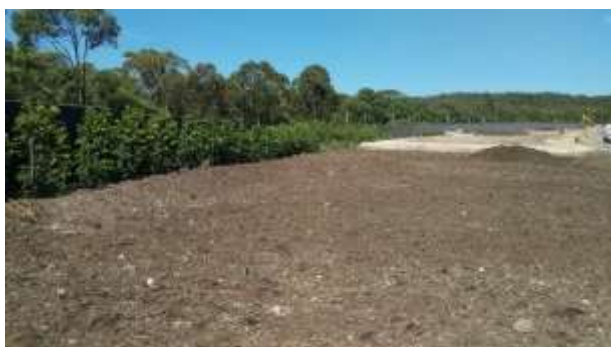
Photograph 5: From Lot 2211, facing southwest.

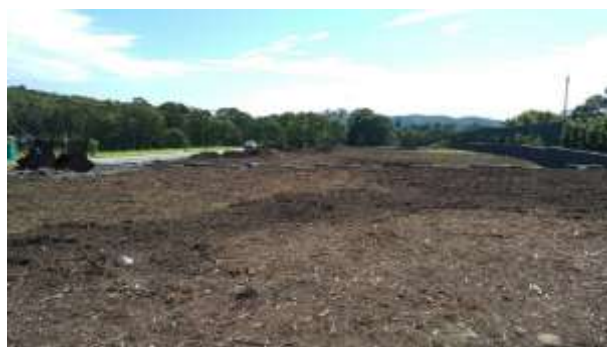
Photograph 6: From Lot 2211, facing northeast.

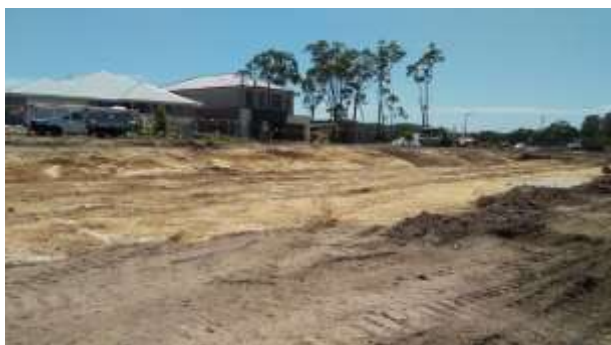
Photograph 7: From near western boundary of Lot 2219, facing northeast.

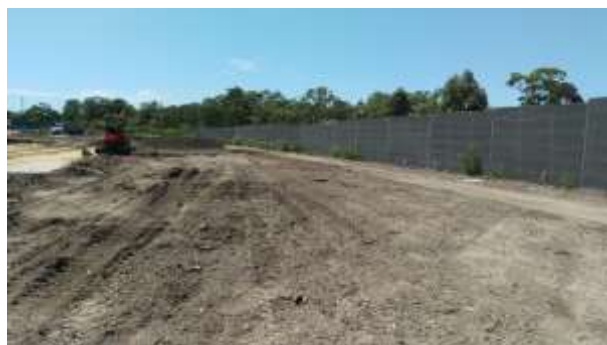
Photograph 8: From near western boundary of Lot 2219, facing east.
