Residential Subdivision  
Billy's Lookout -  
Part Stage 23  
(Lots 2301 to 2315)  
Site Classification

Fishermans Drive,  
Teralba

NEW15P-0070I-AA  
29 January 2020

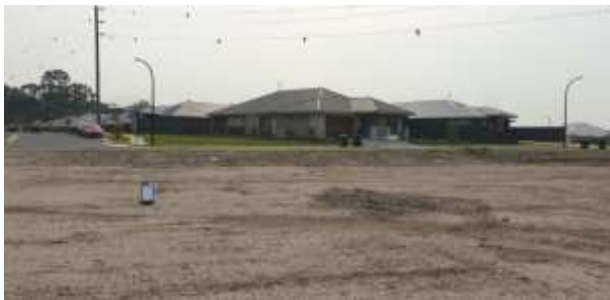
**Photograph 1:** From western boundary of Lot 2302, facing northeast.

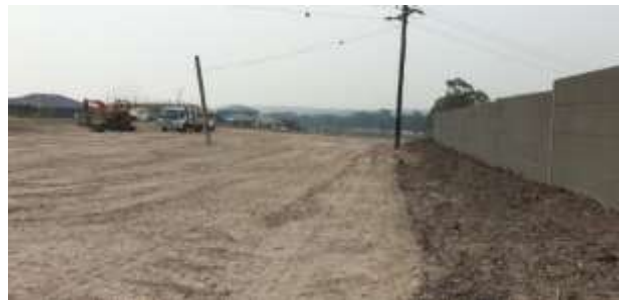
**Photograph 2:** From western boundary of Lot 2302, facing southeast.

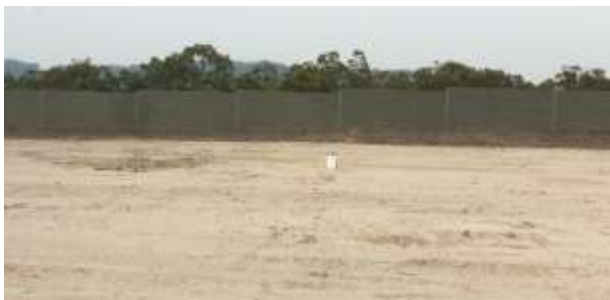
**Photograph 3:** From north-eastern boundary of Lots 2304 & 2305, facing southwest.

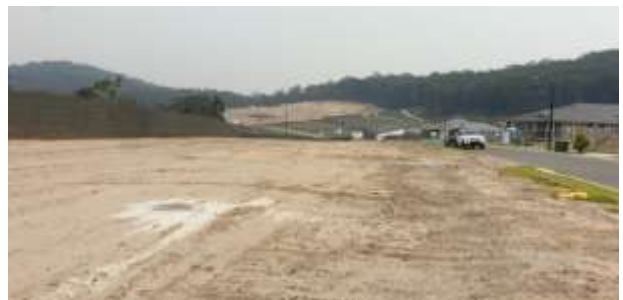
**Photograph 4:** From north-eastern boundary of Lots 2304 & 2305, facing northwest.

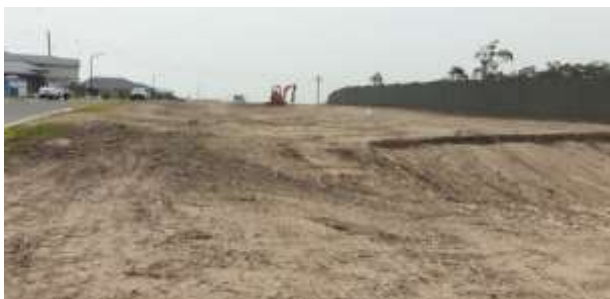
**Photograph 5:** From northern corner of Lot 2310, facing southeast.

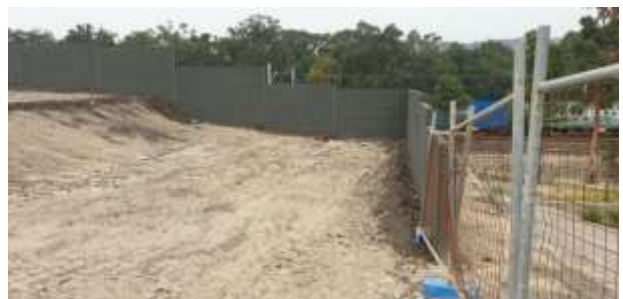
**Photograph 6:** From northern corner of Lot 2310, facing southwest.

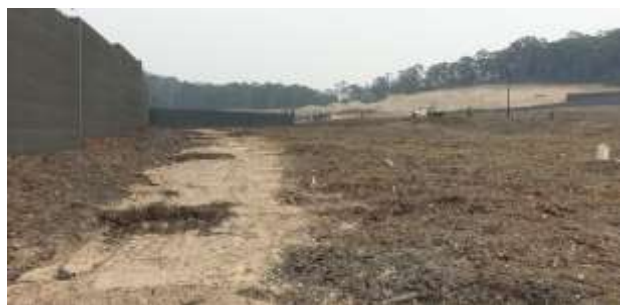
**Photograph 7:** From near south-eastern corner of Lot 2311, facing northwest.

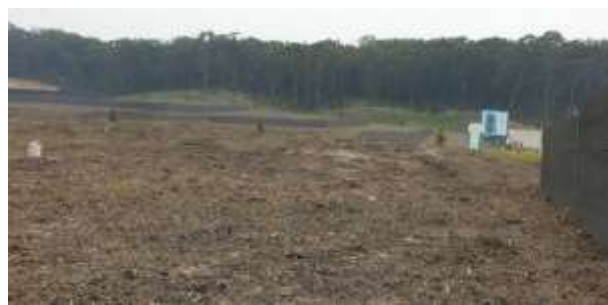
**Photograph 8:** From near south-eastern corner of Lot 2311, facing northeast.
