Proposed Subdivision
Billy's Lookout - Stage 3A
Site Classification

Bowline Street, Teralba

NEW15P-0070G-AB
27 April 2020

**RE: PROPOSED SUBDIVISION – BILLY'S LOOKOUT – STAGE 3A
BOWLINE STREET, TERALBA
SITE CLASSIFICATION**

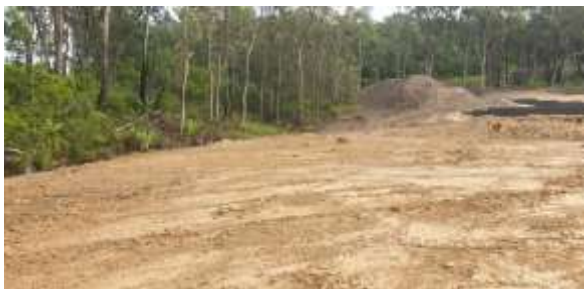
Photograph 1: From near southern boundary of Lot 4, facing northwest.

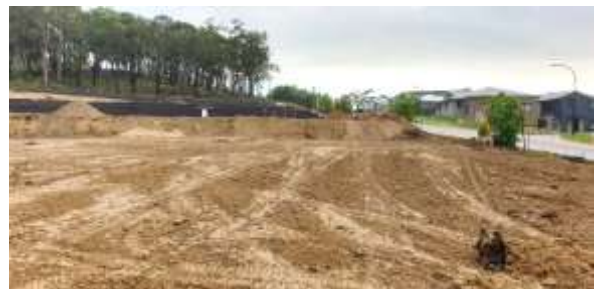
Photograph 2: From near southern boundary of Lot 4, facing north.

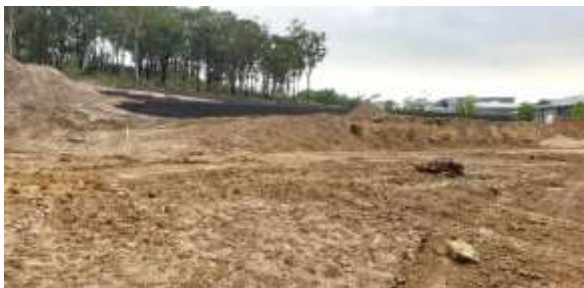
Photograph 3: From near south-western corner of Lot 4, facing north.

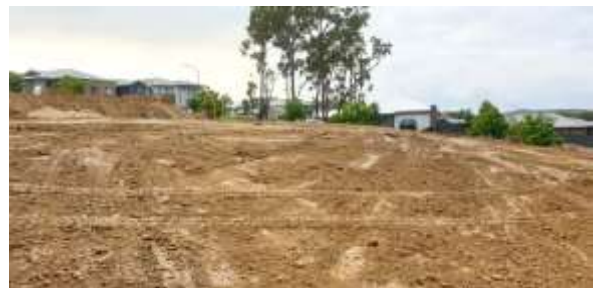
Photograph 4: From near south-western corner of Lot 4, facing east.

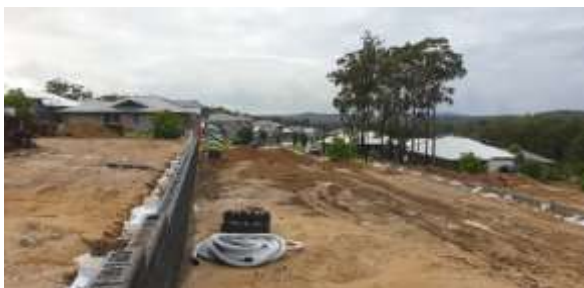
Photograph 5: From western end of shared boundary of Lots 1 and 2, facing east.

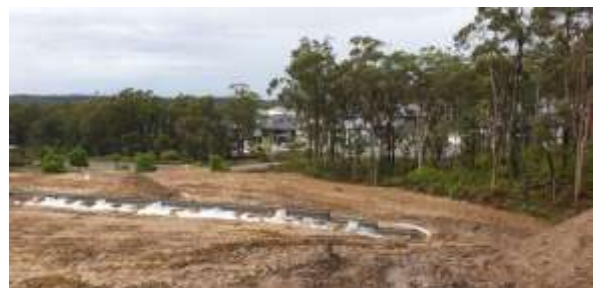
Photograph 6: From western end of shared boundary of Lots 1 and 2, facing southeast.
