Residential Subdivision
Billy's Lookout - Stage 23
Site Classification

Fishermans Drive, Teralba

NEW15P-0070I-AC
24 August 2020

**RE: RESIDENTIAL SUBDIVISION – BILLY'S LOOKOUT – STAGE 23
FISHERMANS DRIVE, TERALBA
SITE CLASSIFICATION (LOTS 2301 to 2323)**

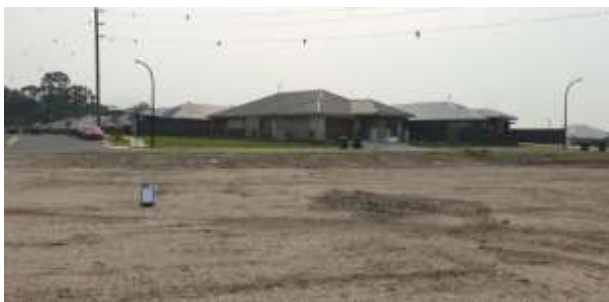
Photograph 1: From western boundary of Lot 2302, facing northeast.

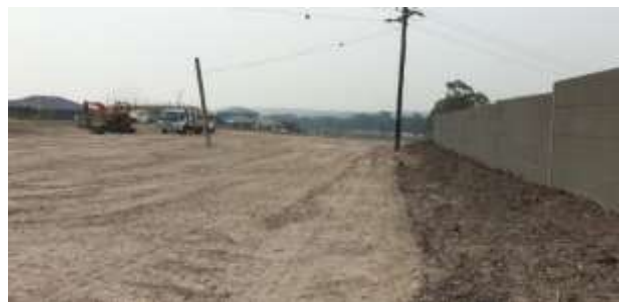
Photograph 2: From western boundary of Lot 2302, facing southeast.

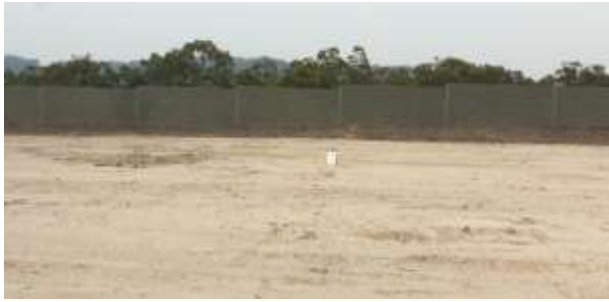
Photograph 3: From north-eastern boundary of Lots 2304 & 2305, facing southwest.

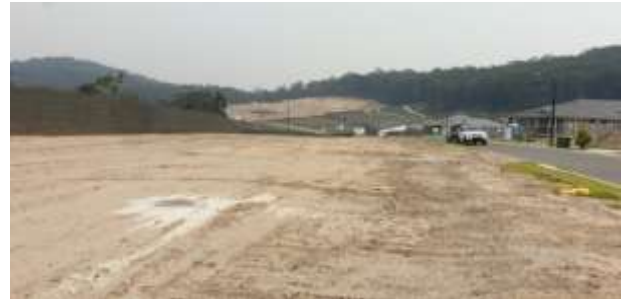
Photograph 4: From north-eastern boundary of Lots 2304 & 2305, facing northwest.

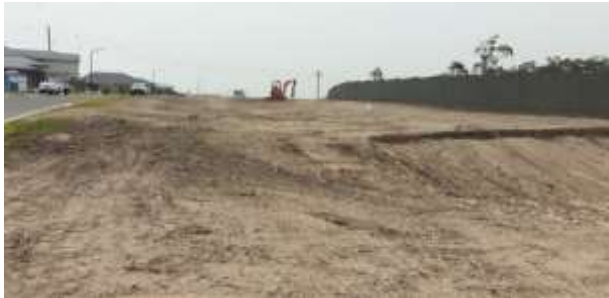
Photograph 5: From northern corner of Lot 2310, facing southeast.

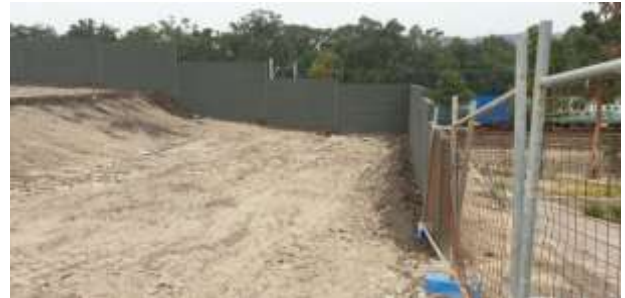
Photograph 6: From northern corner of Lot 2310, facing southwest.

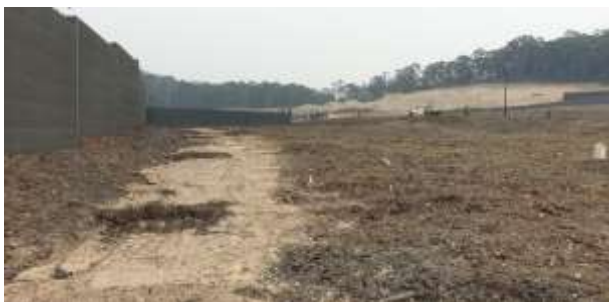
Photograph 7: From near south-eastern corner of Lot 2311, facing northwest.

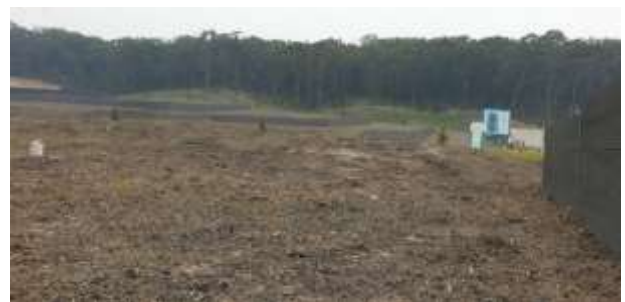
Photograph 8: From near south-eastern corner of Lot 2311, facing northeast.

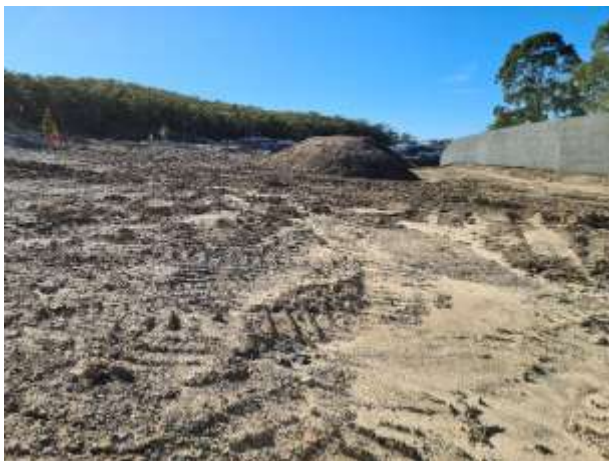
Photograph 9: From near BH2313, facing east, fill stockpile visible in background.

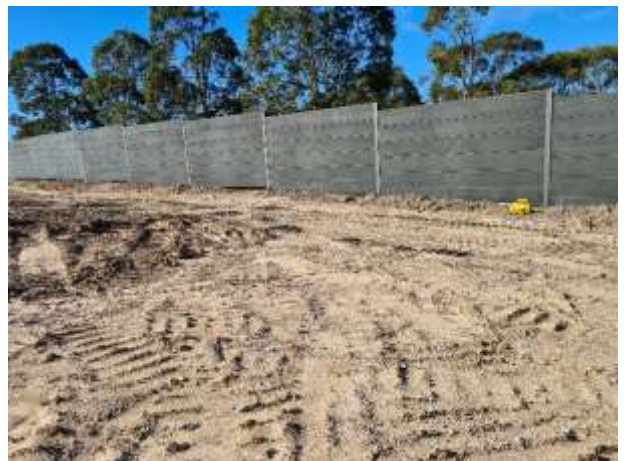
Photograph 10: From near BH2313, facing southeast.

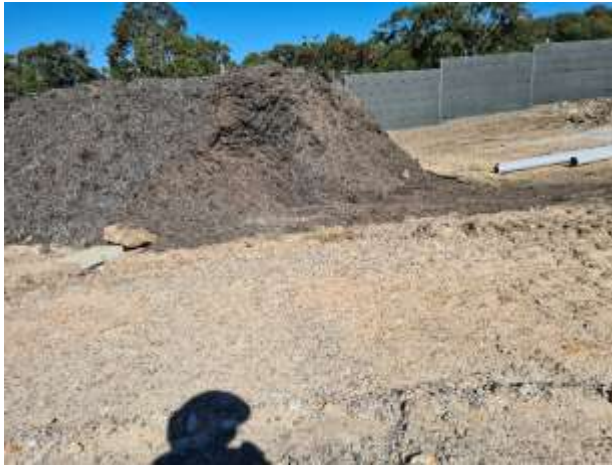
Photograph 11: From approximately 5m northeast of BH2310, facing southwest. Shows tree mulch stockpile on Lots 2316 and 2317.

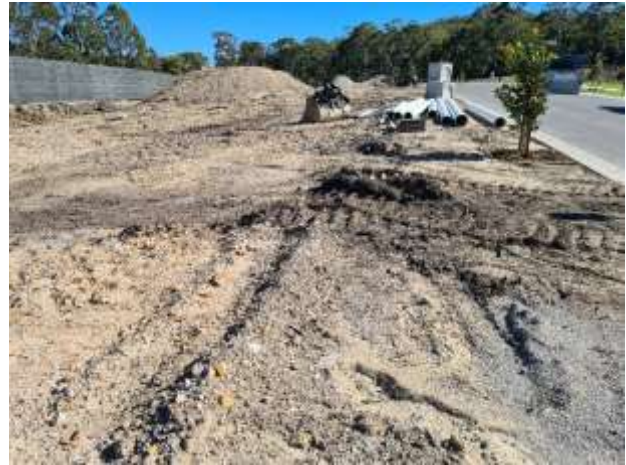
Photograph 12: From approximately 5m northeast of BH2310, facing west. Fill stockpile on Lots 2319 and 2320 visible in background.
