Proposed Subdivision Billy's Lookout -Stages 6 & 9 Site Classification

Fishermans Drive, Teralba

NEW15P-0070A-AJ 15 November 2017

RE: PROPOSED SUBDIVISION – BILLY'S LOOKOUT – STAGES 6 & 9
FISHERMANS DRIVE, TERALBA
SITE CLASSIFICATION (LOTS 601 TO 614 & 901 TO 926)

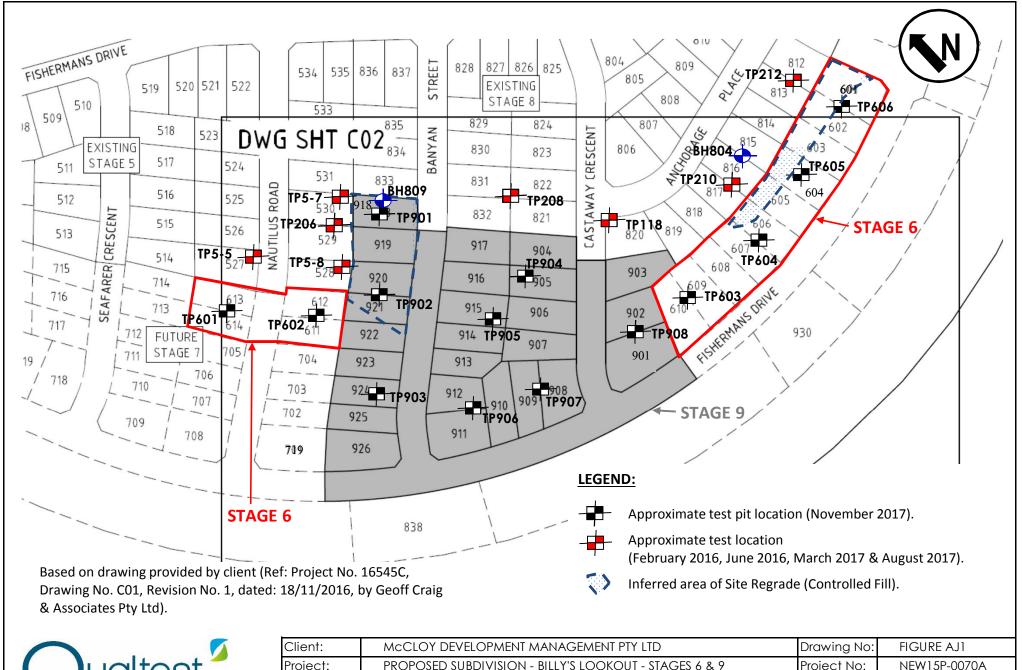
Figure AJ1 –Approximate Test Location Plan

The recommendations of this report are based on the understanding that any existing lot re-grade works outside the areas shown on Figure AJ1, and described above are limited to cutting and/or placement of fill including topsoil to depths of less than 0.4m, in general accordance with the design. Qualtest should be informed without delay if additional earthworks are known to have been carried out.
