Proposed Subdivision  
Billy's Lookout –  
Stages 16 & 17  
Site Classification

Outrigger Drive, Teralba

NEW15P-0070F-AE  
11 July 2023

**RE: RESIDENTIAL SUBDIVISION – BILLY'S LOOKOUT – STAGES 16 & 17  
OUTRIGGER DRIVE, TERALBA  
SITE CLASSIFICATION (LOTS 1601 TO 1617 AND 1701 TO 1706)**

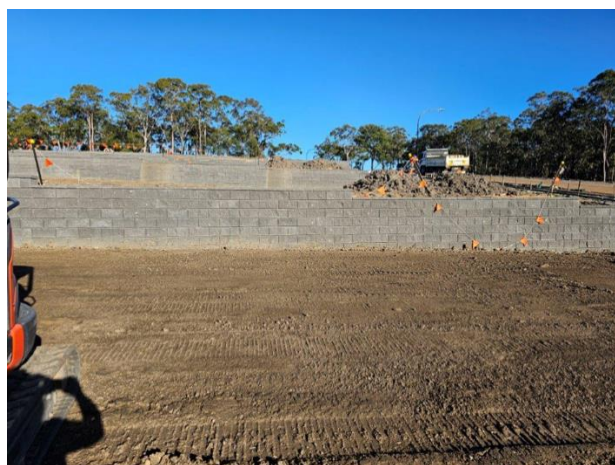
**Photograph 1:** From Lot 1606, (near BH1601), facing west.

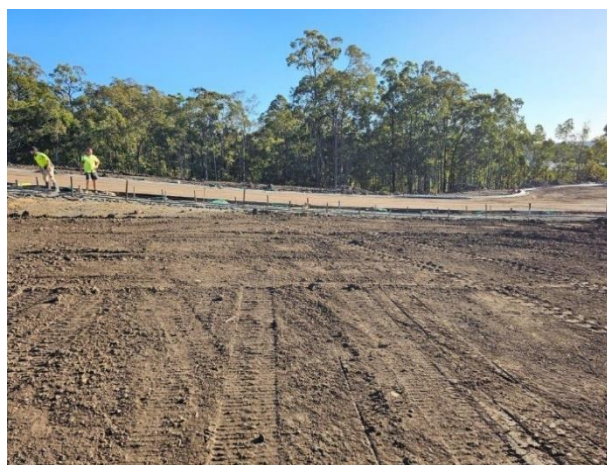
**Photograph 2:** From Lot 1606, (near BH1601), facing north.

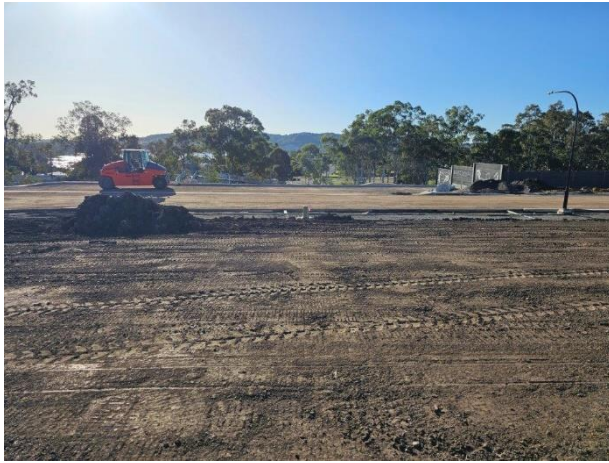
**Photograph 3:** From Lot 1607, (near BH1601), facing northeast. Showing Outrigger Drive in background.

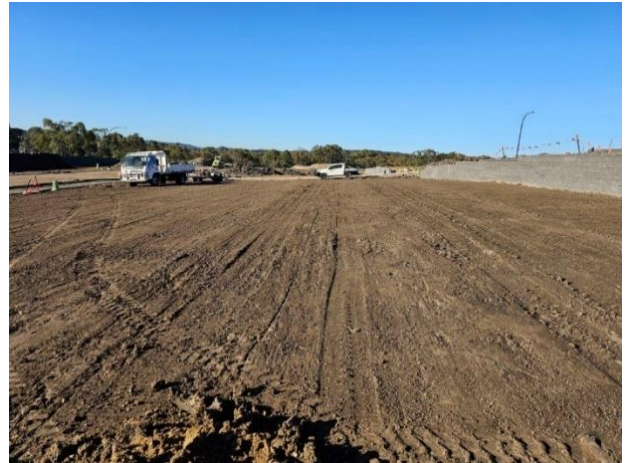
**Photograph 4:** From Lot 1607, (near BH1601), facing southeast.

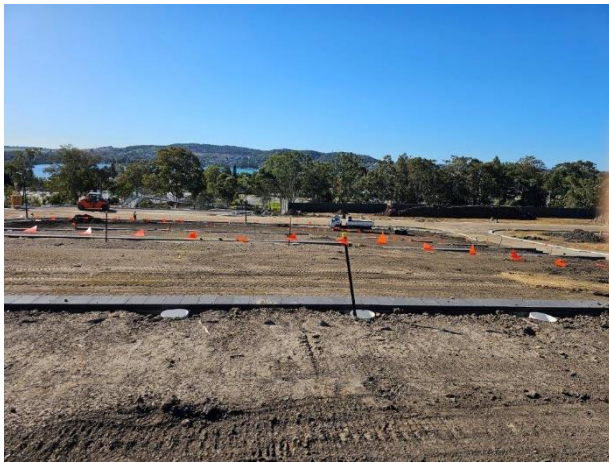
**Photograph 5:** From Lot 1612, (near BH1606), facing east.

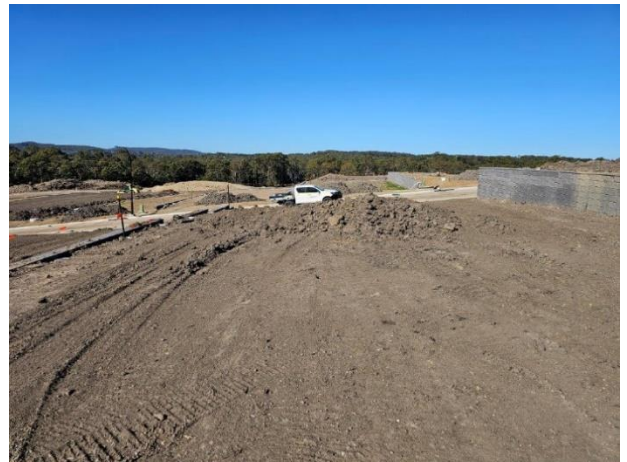
**Photograph 6:** From Lot 1612, (near BH1606), facing southeast.

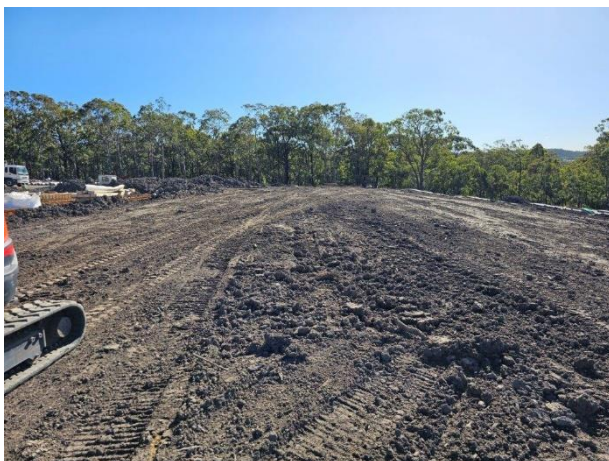
**Photograph 7:** From Lot 1702, (near BH1701), facing northwest.

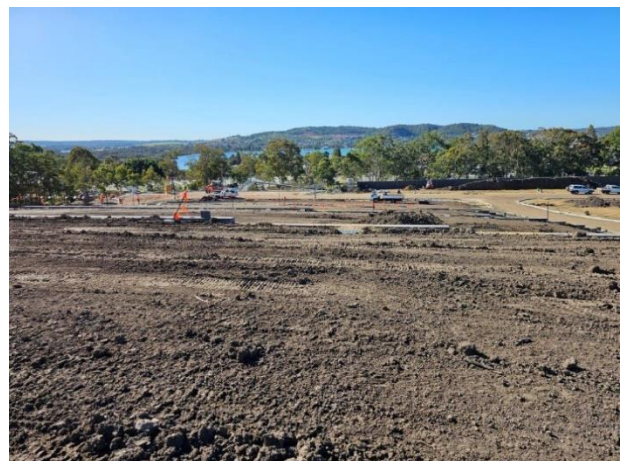
**Photograph 8:** From Lot 1702, (near BH1701), facing northeast.

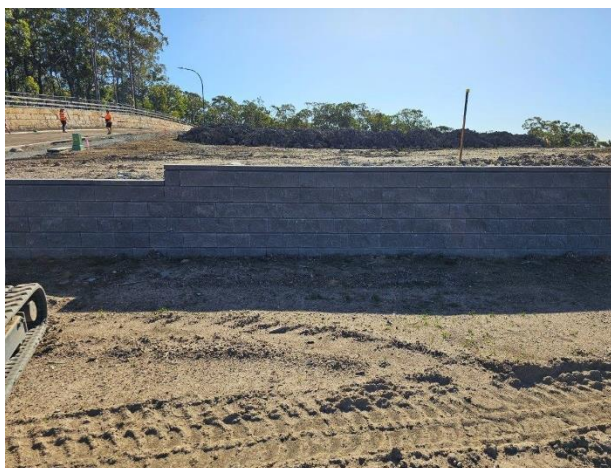
**Photograph 9:** From Lot 1705, (near BH1704), facing northwest.

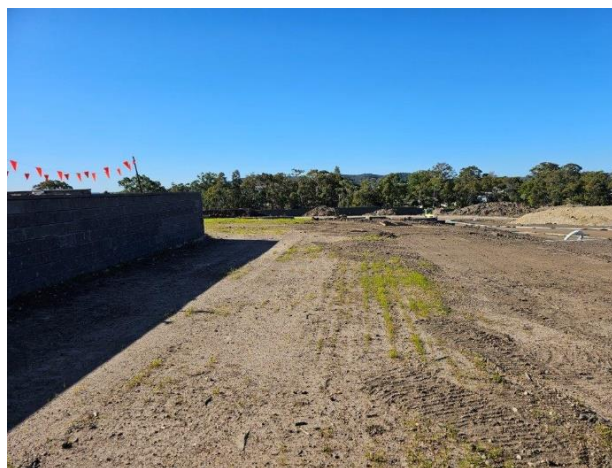
**Photograph 10:** From Lot 1706, (near BH1705), facing northeast.

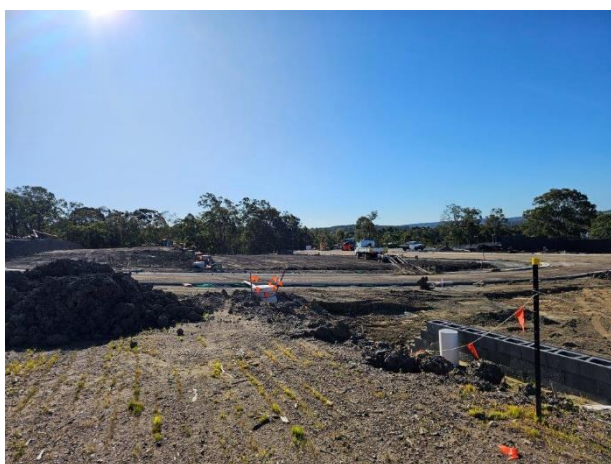
**Photograph 11:** From Lot 1615, (near BH1609), facing north.

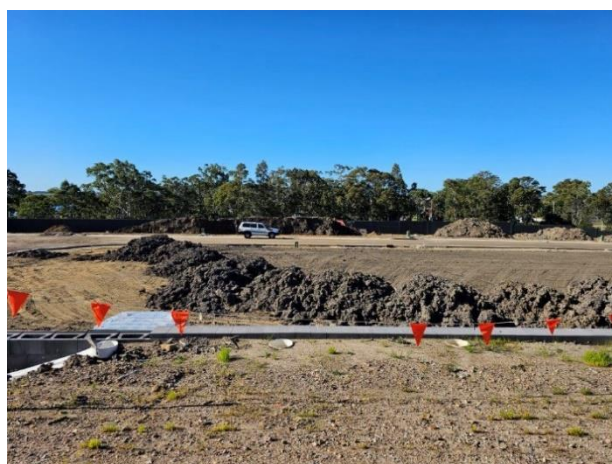
**Photograph 12:** From Lot 1615, (near BH1609), facing northeast.
