Proposed Subdivision
Billy's Lookout – Stage 24
Site Classification

Outrigger Drive, Teralba

NEW15P-0070F-AF
24 July 2023

**RE: RESIDENTIAL SUBDIVISION – BILLY'S LOOKOUT – STAGE 24
OUTRIGGER DRIVE, TERALBA
SITE CLASSIFICATION (LOTS 2401 TO 2417)**

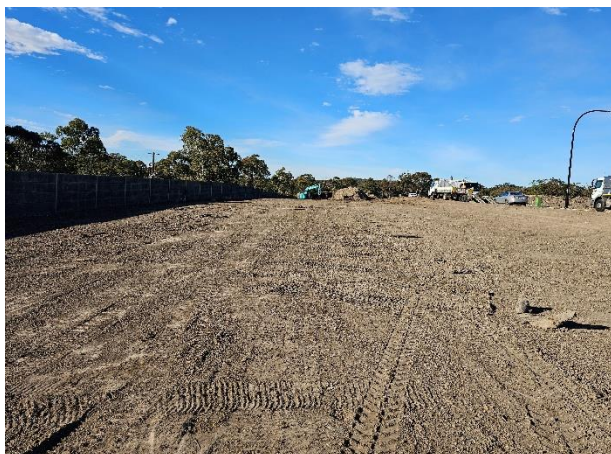
Photograph 1: From boundary of Lots 2401 and 2402, (near BH2401), facing south.

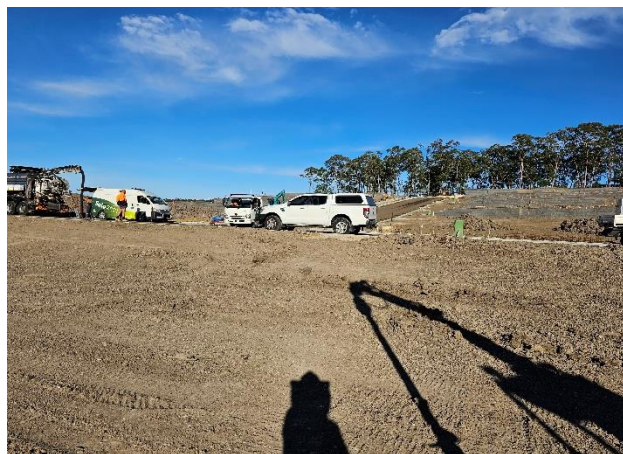
Photograph 2: From boundary of Lots 2401 and 2402, (near BH2401), facing southwest.

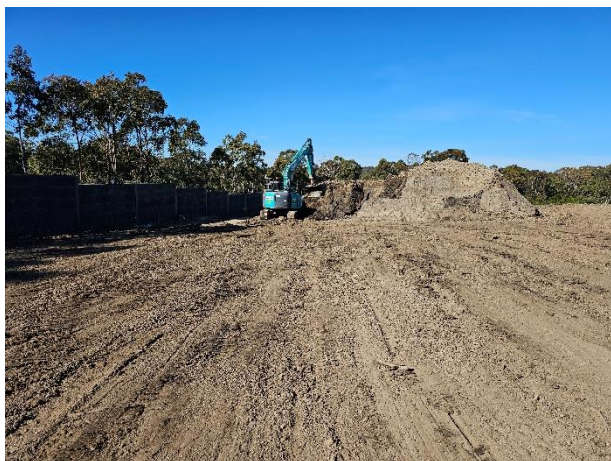
Photograph 3: From boundary of Lots 2407 and 2408, (near BH2404), facing south. Showing topsoil stockpile on Lots 2410 to 2414.

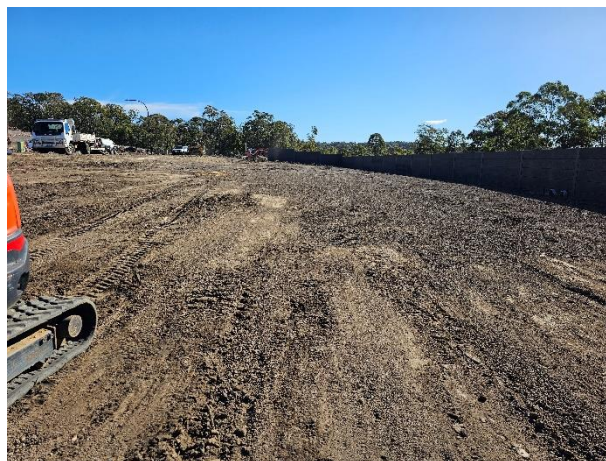
Photograph 4: From boundary of Lots 2407 and 2408, (near BH2404), facing northwest.

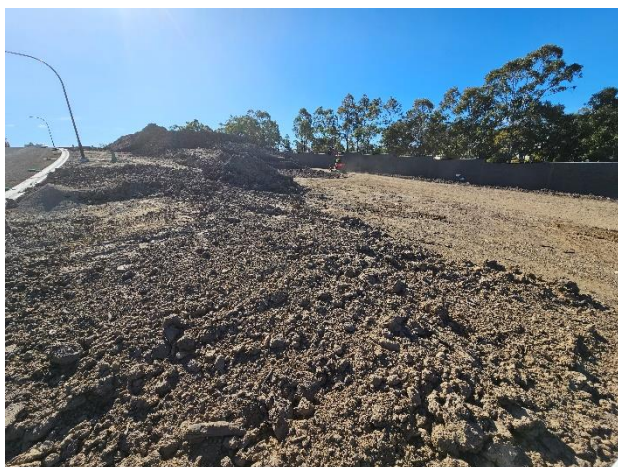
Photograph 5: From near corner of Lots 2415 and 2416, (approx. 10m west of BH2408), facing north.

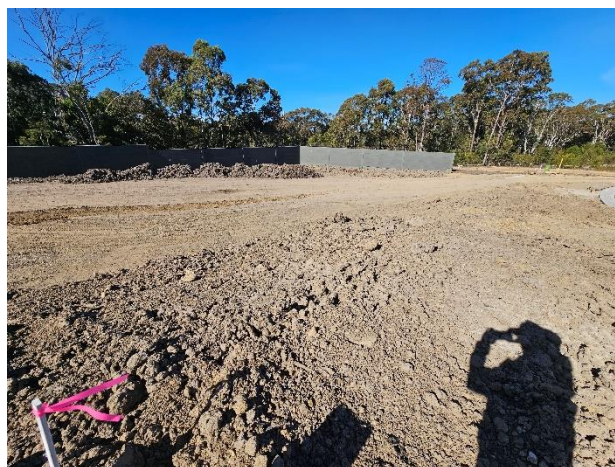
Photograph 6: From near corner of Lots 2415 and 2416, (approx. 10m west of BH2408), facing southeast.
