Proposed Subdivision
Billy's Lookout - Stage 3A
Site Classification

Bowline Street, Teralba

NEW15P-0070G-AB
27 April 2020

**RE: PROPOSED SUBDIVISION – BILLY'S LOOKOUT – STAGE 3A
BOWLINE STREET, TERALBA
SITE CLASSIFICATION**

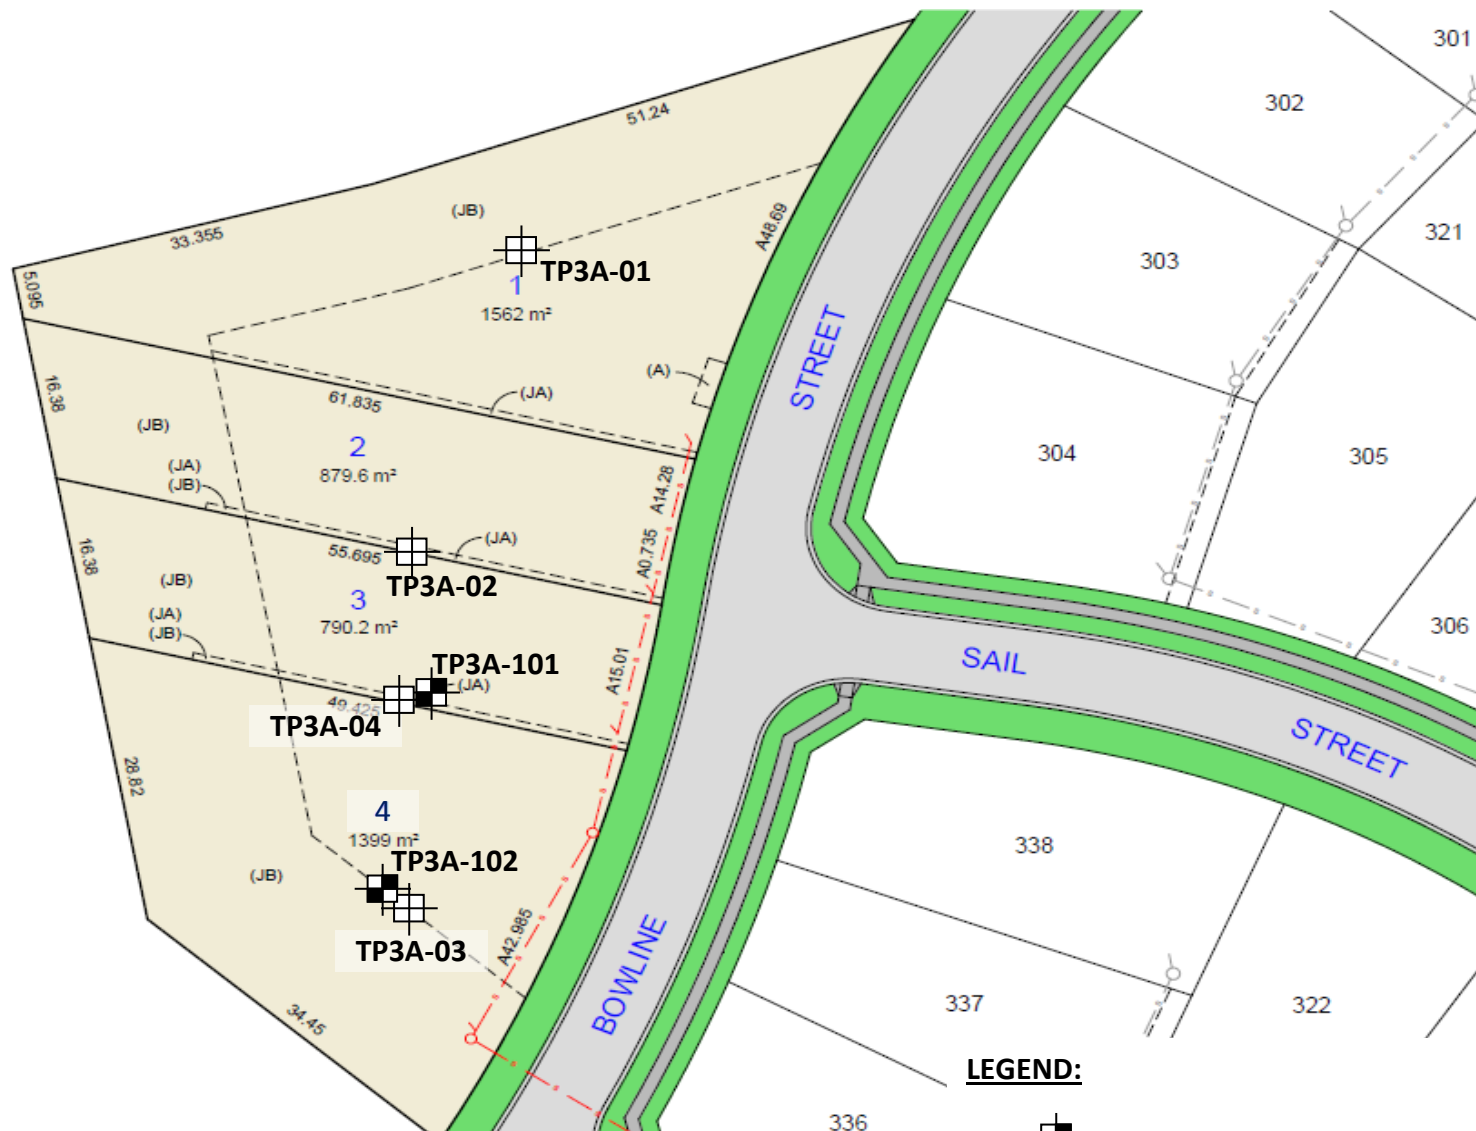
FIGURE AB1:

Based on the results of the field work and laboratory testing, residential lots located within Stage 3A of the Billy's Lookout subdivision located off Bowline Street, Teralba, as shown on Figure AB1, are classified in their current condition in accordance with AS2870-2011 'Residential Slabs and Footings', as shown in Table 4.

Site Plan and Approximate Test Locations
