Proposed Subdivision
Billy's Lookout - Stage 2
Site Classification

Pitt Street, Teralba

NEW15P-0070D-AA
17 October 2018

**RE: PROPOSED SUBDIVISION – BILLY'S LOOKOUT – STAGE 2
PITT STREET, TERALBA
SITE CLASSIFICATION (LOTS 201 TO 215)**

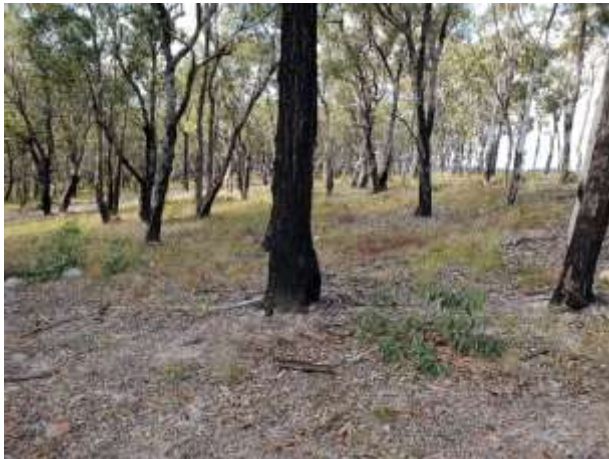
Photograph 1: Facing southeast from near TPQ-203.

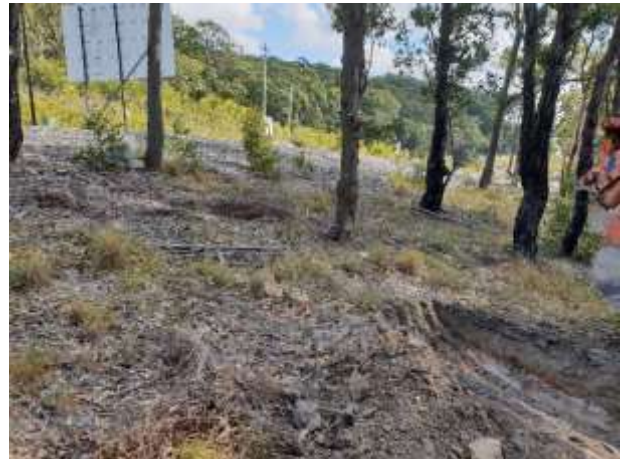
Photograph 2: Facing northwest from near TPQ-203. Test pit TPQ-203 visible in bottom right corner of photo.

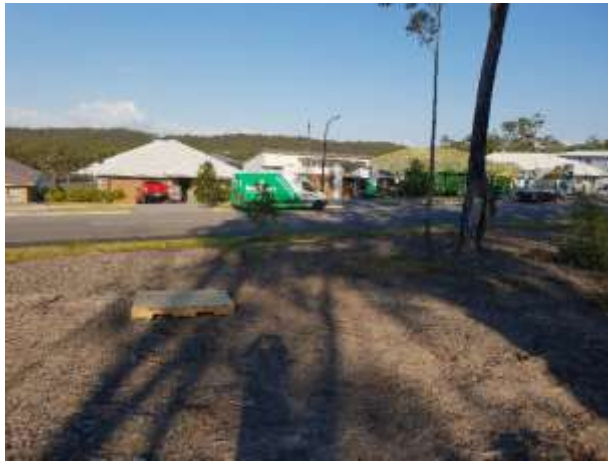
Photograph 5: Facing southwest from near TPQ-208, Pitt Street visible.

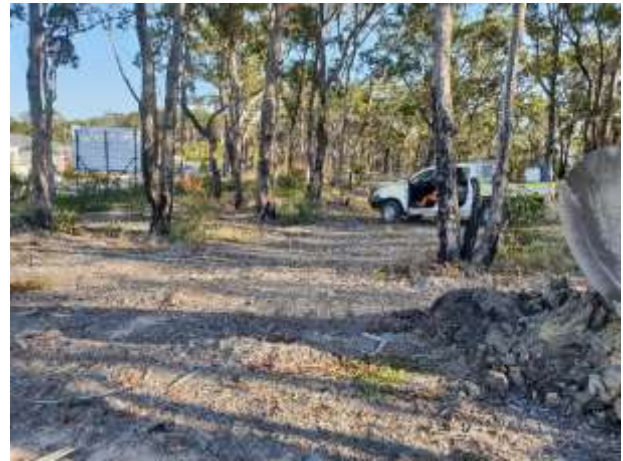
Photograph 6: Facing northwest from near TPQ-208. TPQ-208 visible in right of photo.
