Proposed Subdivision Stages 3 & 4 Pitt Street, Teralba Geotechnical Assessment

Pitt Street, Teralba

NEW15P-0070-AA.Rev1 28 August 2015

RE: PROPOSED SUBDIVISION - STAGES 3 & 4 PITT STREET, TERALBA GEOTECHNICAL ASSESSMENT

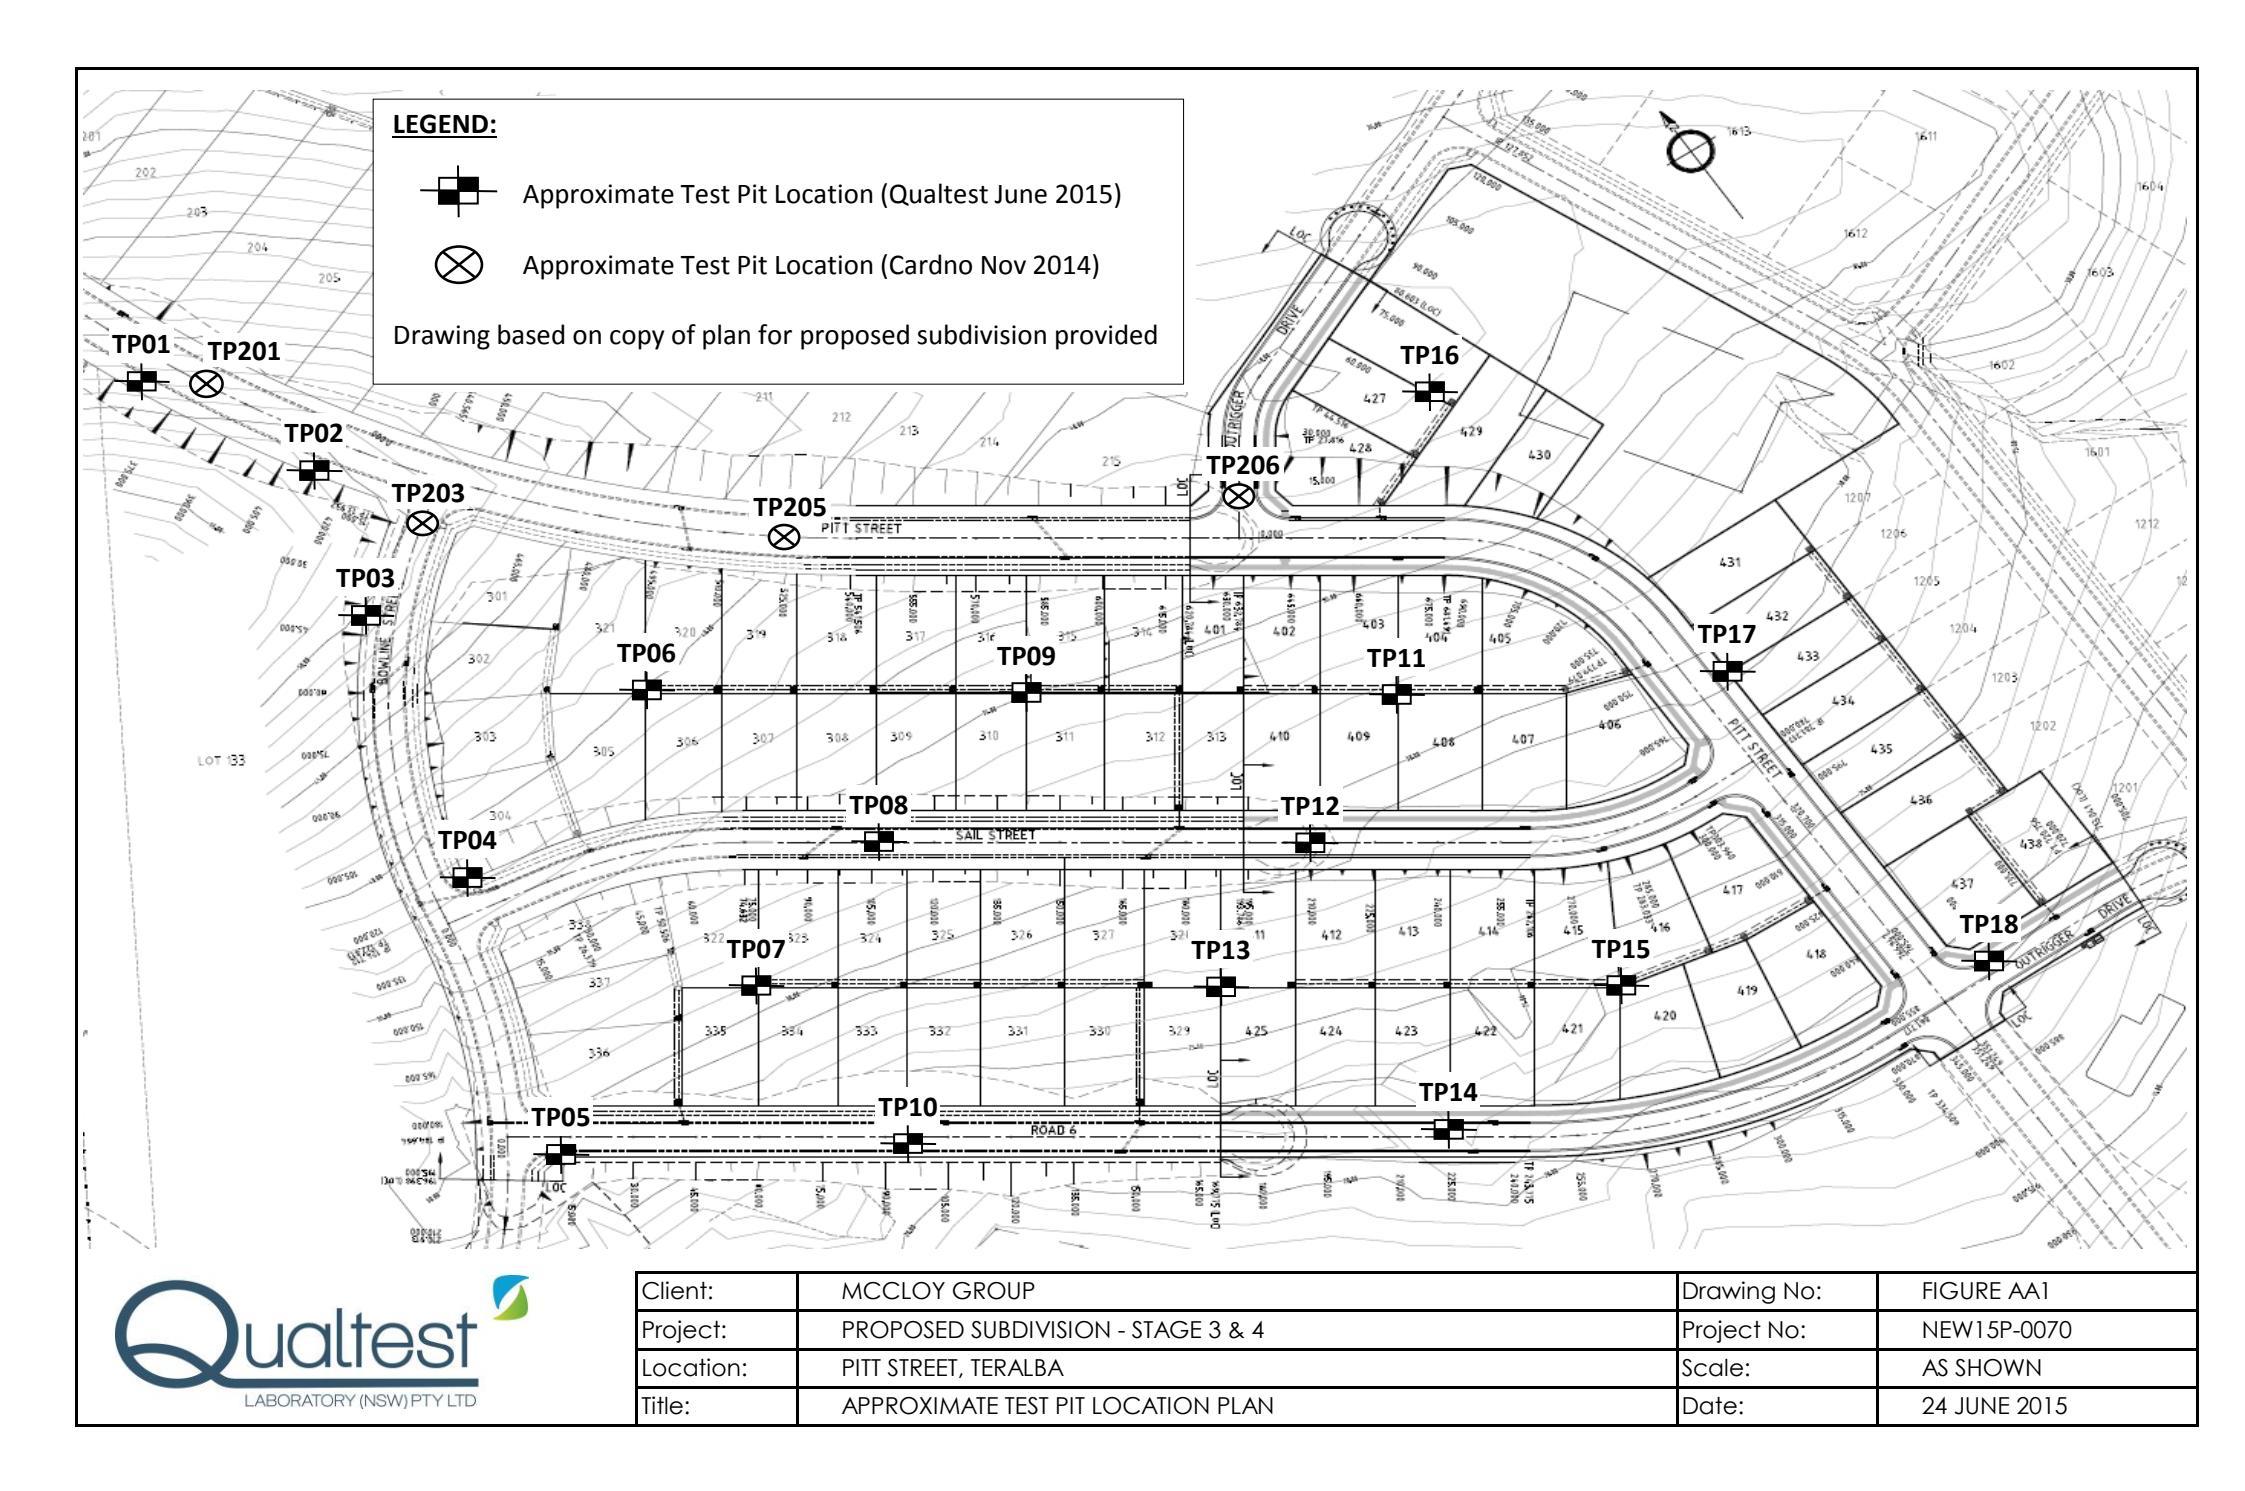
FIGURE AA1:

Approximate Test Pit Location Plan

Based on the results of the field work and laboratory testing, residential lots located within the proposed subdivision of Stages 3 & 4, Pitt Street, Teralba, as shown on Figure AA1, are classified in their current condition in accordance with AS2870-2011 '*Residential Slabs and Footings*', as shown in Table 6.
