BUSHFIRE ATTACK LEVEL

**FOR
FUTURE DWELLINGS**

**AT STAGE 7
BILLY'S LOOKOUT
TERALBA**

Site Details:	Stage 7 at Billy's Lookout, Teralba
Prepared by:	<i>Sarah Jones B.Env.Sc.,G.Dip.DBPA (Design in Bushfire Prone Areas)</i> <i>Firebird ecoSultants Pty Ltd</i> ABN – 16 105 985 993 PO Box 354, Newcastle NSW 2300 M: 0414 465 990 Email: sarah@firebirdeco.com.au T: 02 4910 3939 Fax: 02 4929 2727
Prepared for:	McCloy Teralba
Reference No.	Teralba - McCloy
Document Status & Date:	November 2017

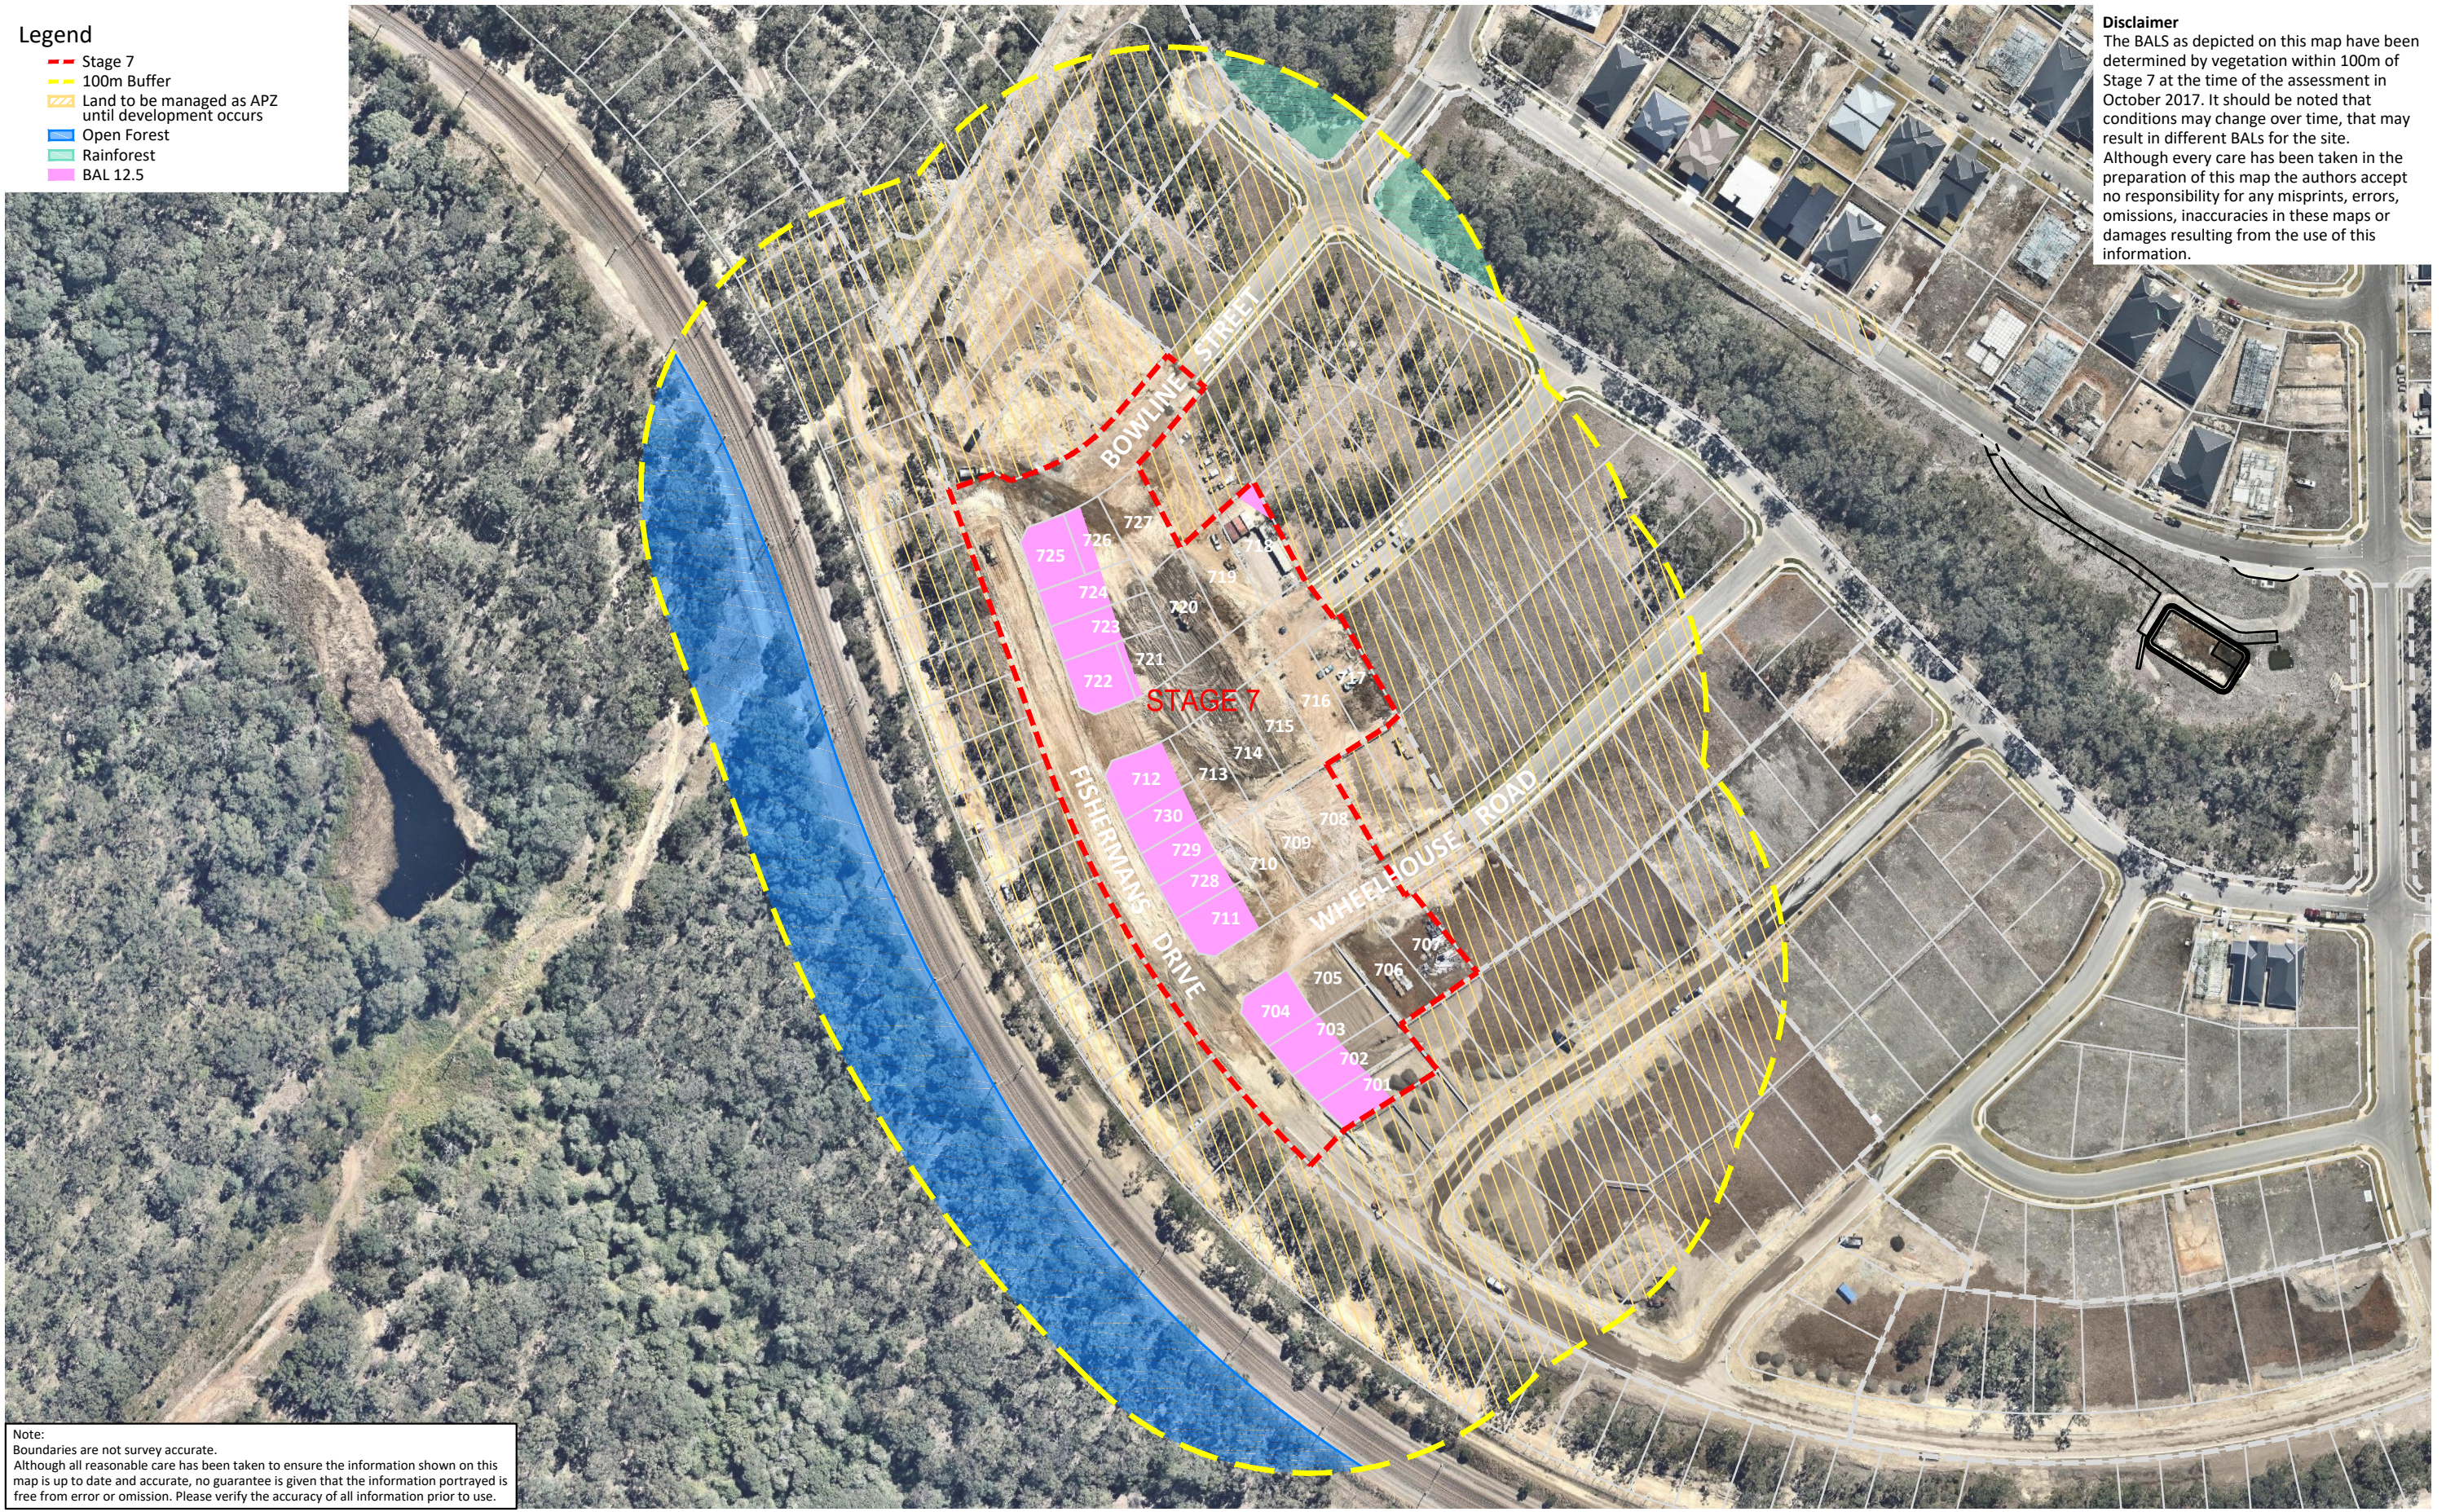
FIGURE 4-1: BUSHFIRE ATTACK LEVELS MAP

The results from this bush fire attack assessment are detailed below in Table 4-1– Bushfire Attack Level (BAL) Assessment and Figure 4-1 Bushfire Attack Level Map.

- Stage 7
- 100m Buffer
- Land to be managed as APZ until development occurs
- Open Forest
- Rainforest
- BAL 12.5

Lot Number	Vegetation Type within 100m & Direction from future dwellings	Average Slope of Land (degrees)	Separation Distance from Identified Vegetation	Bushfire Attack Level (BAL)	Construction Section
Lot 701	Open Forest to the South-west	Downslope 0-5 degrees	57-<100m	BAL-12.5	Sect 3 & 7 of AS3959 and Sect A3.7 of PBP Addendum Appendix 3
			≥100m	BAL-LOW	No requirements
Lot 702	Open Forest to the South-west	Downslope 0-5 degrees	57-<100m	BAL-12.5	Sect 3 & 7 of AS3959 and Sect A3.7 of PBP Addendum Appendix 3
			≥100m	BAL-LOW	No requirements
Lot 703	Open Forest to the South-west	Downslope 0-5 degrees	57-<100m	BAL-12.5	Sect 3 & 7 of AS3959 and Sect A3.7 of PBP

No BALs applies to any future dwelling built greater than 100m from the Open Forest.

This report and mapping are not to be used to place wholesale restrictions on lots reflecting the resulting BAL mapping presented within. Building location and design will influence the application of the required BALs. For example, a lot indicated as being affected by BAL-29 may have those facades that are not exposed to the bushfire threat constructed to a lower BAL (i.e. BAL-19), reducing the costs of construction and providing more flexibility in choice of external building materials.
