BUSHFIRE ATTACK LEVEL

**FOR
FUTURE DWELLINGS**

**AT STAGE 3A
BILLY'S LOOKOUT
TERALBA**

Firebird ecoSultants Pty Ltd

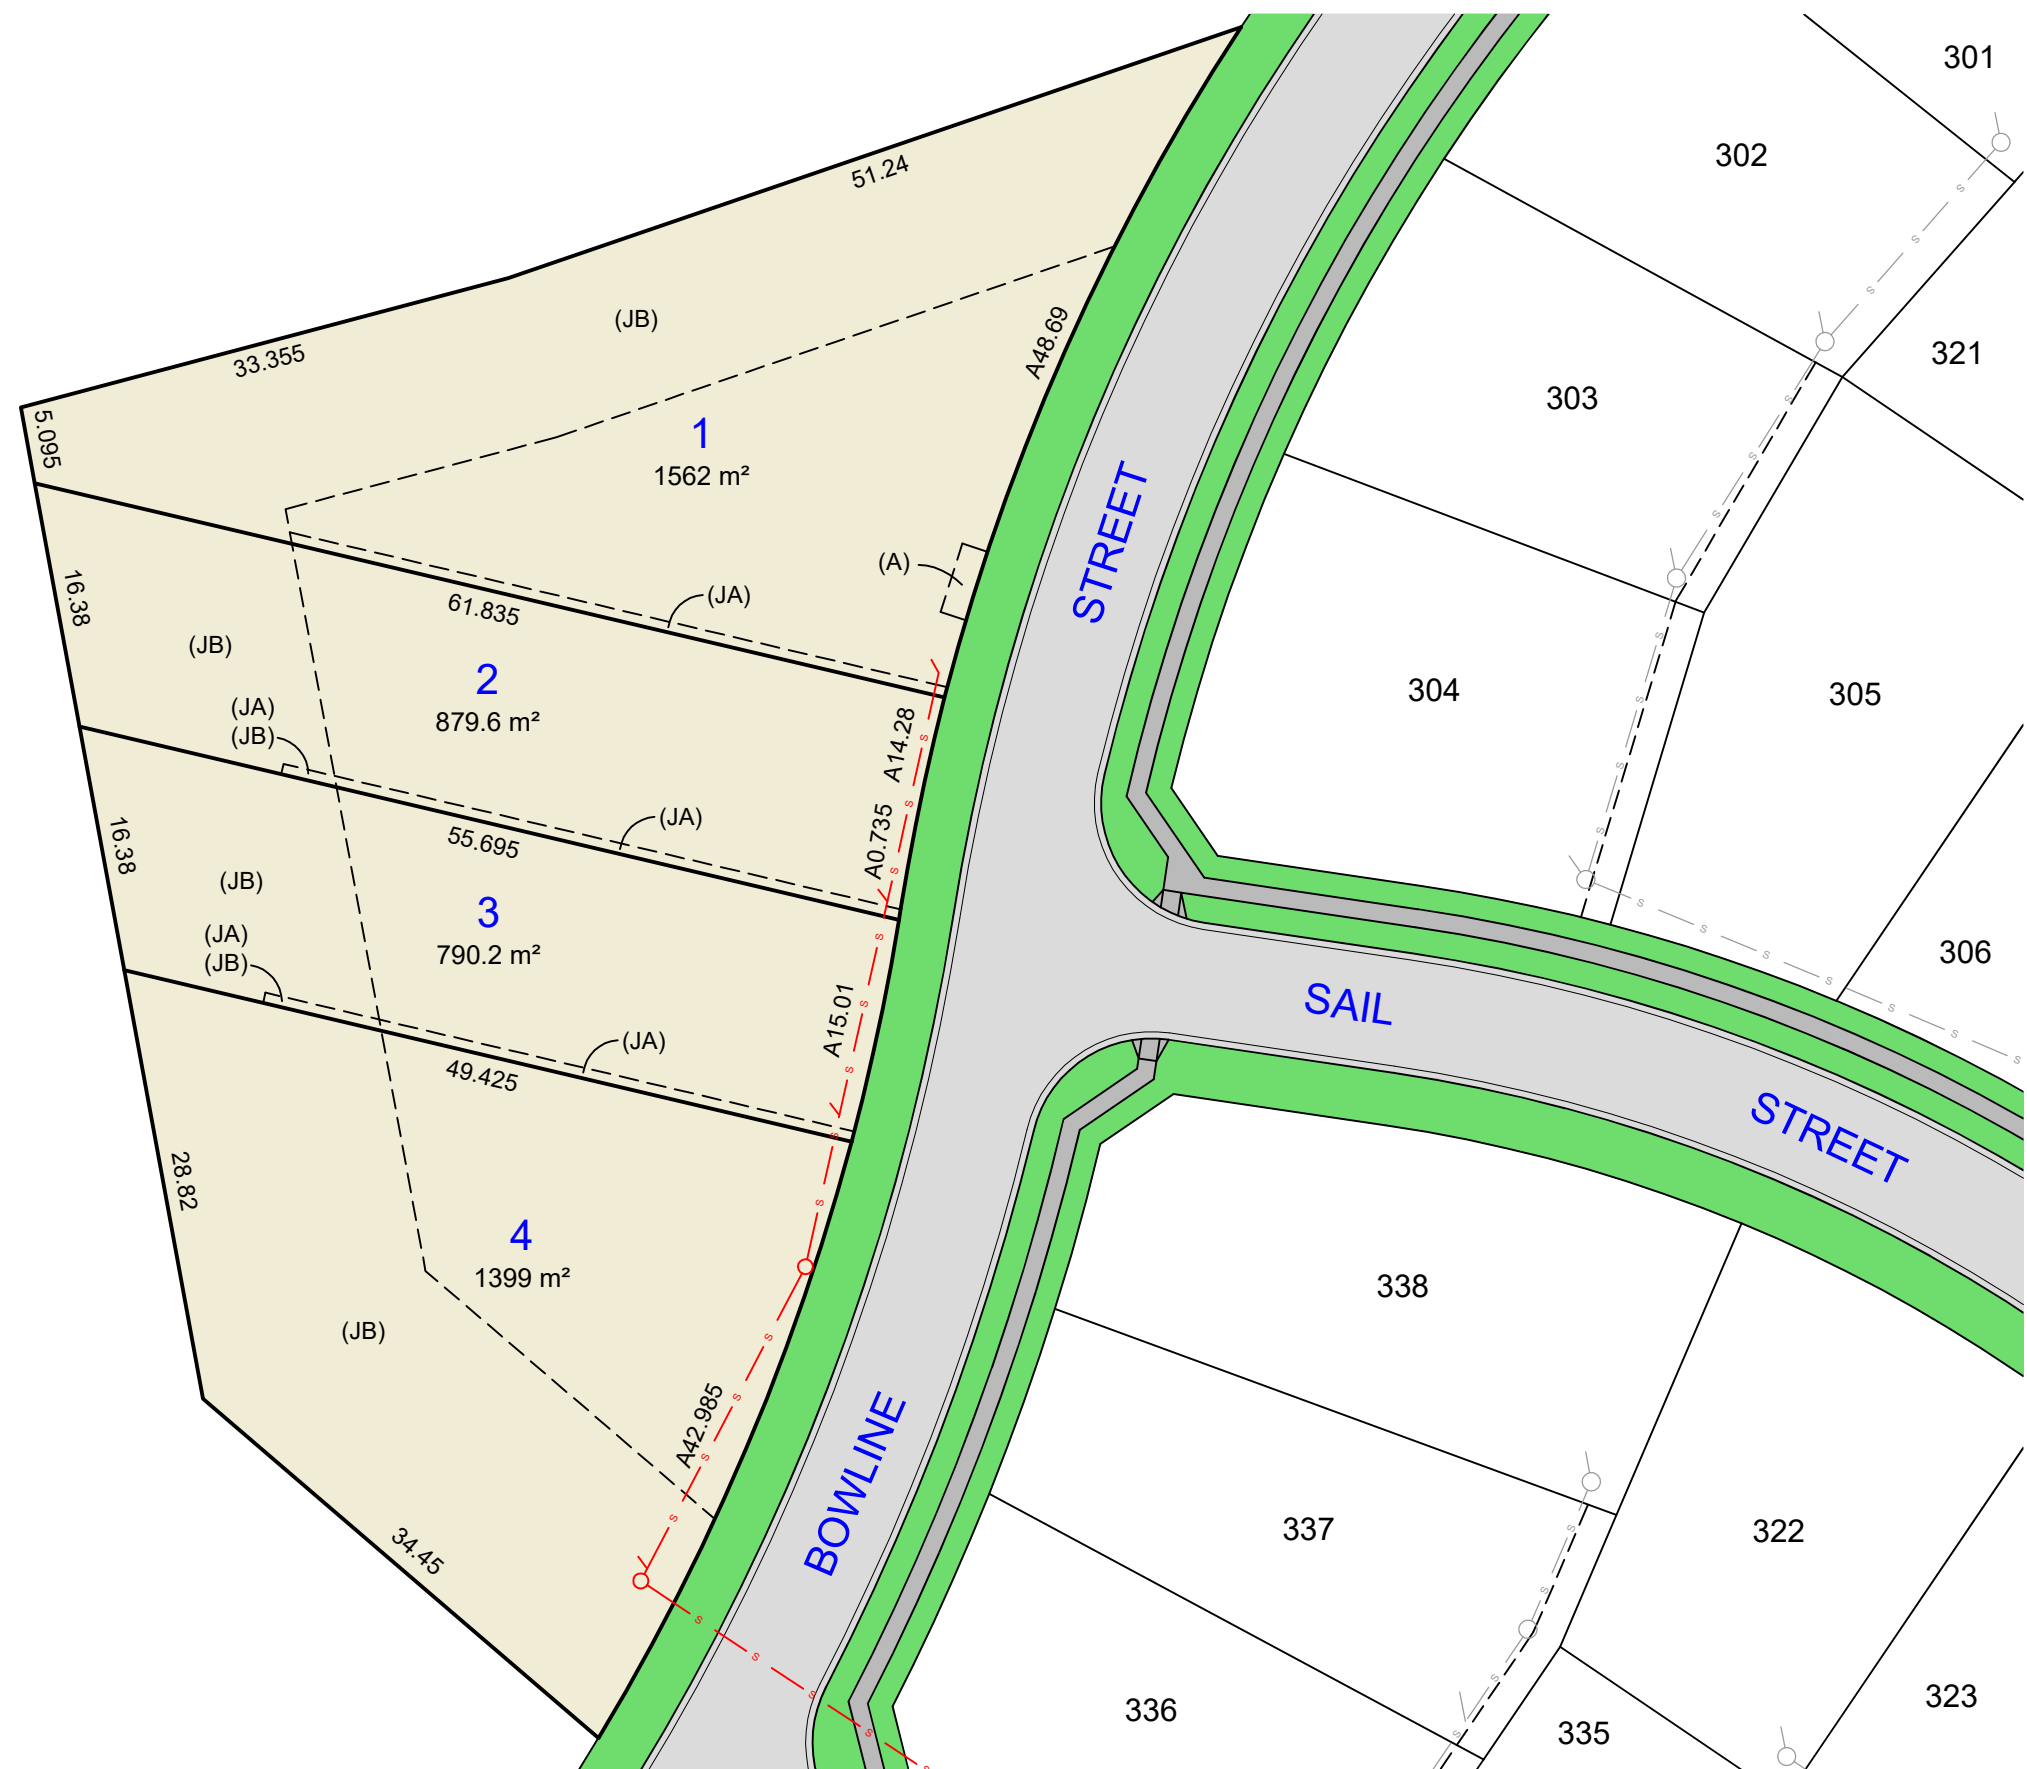
SALE PLAN FOR BILLY'S LOOKOUT STAGE 3A

- (A) - EASEMENT FOR ELECTRICITY & OTHER PURPOSES 4.75 WIDE (D.P.1222057)
(JA) - RESTRICTION ON THE USE OF LAND
(JB) - POSITIVE COVENANT

— s — s — s — s — PROPOSED SEWER LINE

Firebird ecoSultants Pty Ltd has been engaged by Teralba McCloys Pty Ltd to undertake a Bushfire Attack Level (BAL) report for Stage 3A at Billy's Lookout, Teralba hereafter referred to as the "site". Refer to Appendix A for Sales Plan.
