BUSHFIRE ATTACK LEVEL

FOR FUTURE DWELLINGS AT STAGE 24 BILLY'S LOOKOUT TERALBA

FIGURE 4-1: BUSHFIRE ATTACK LEVELS

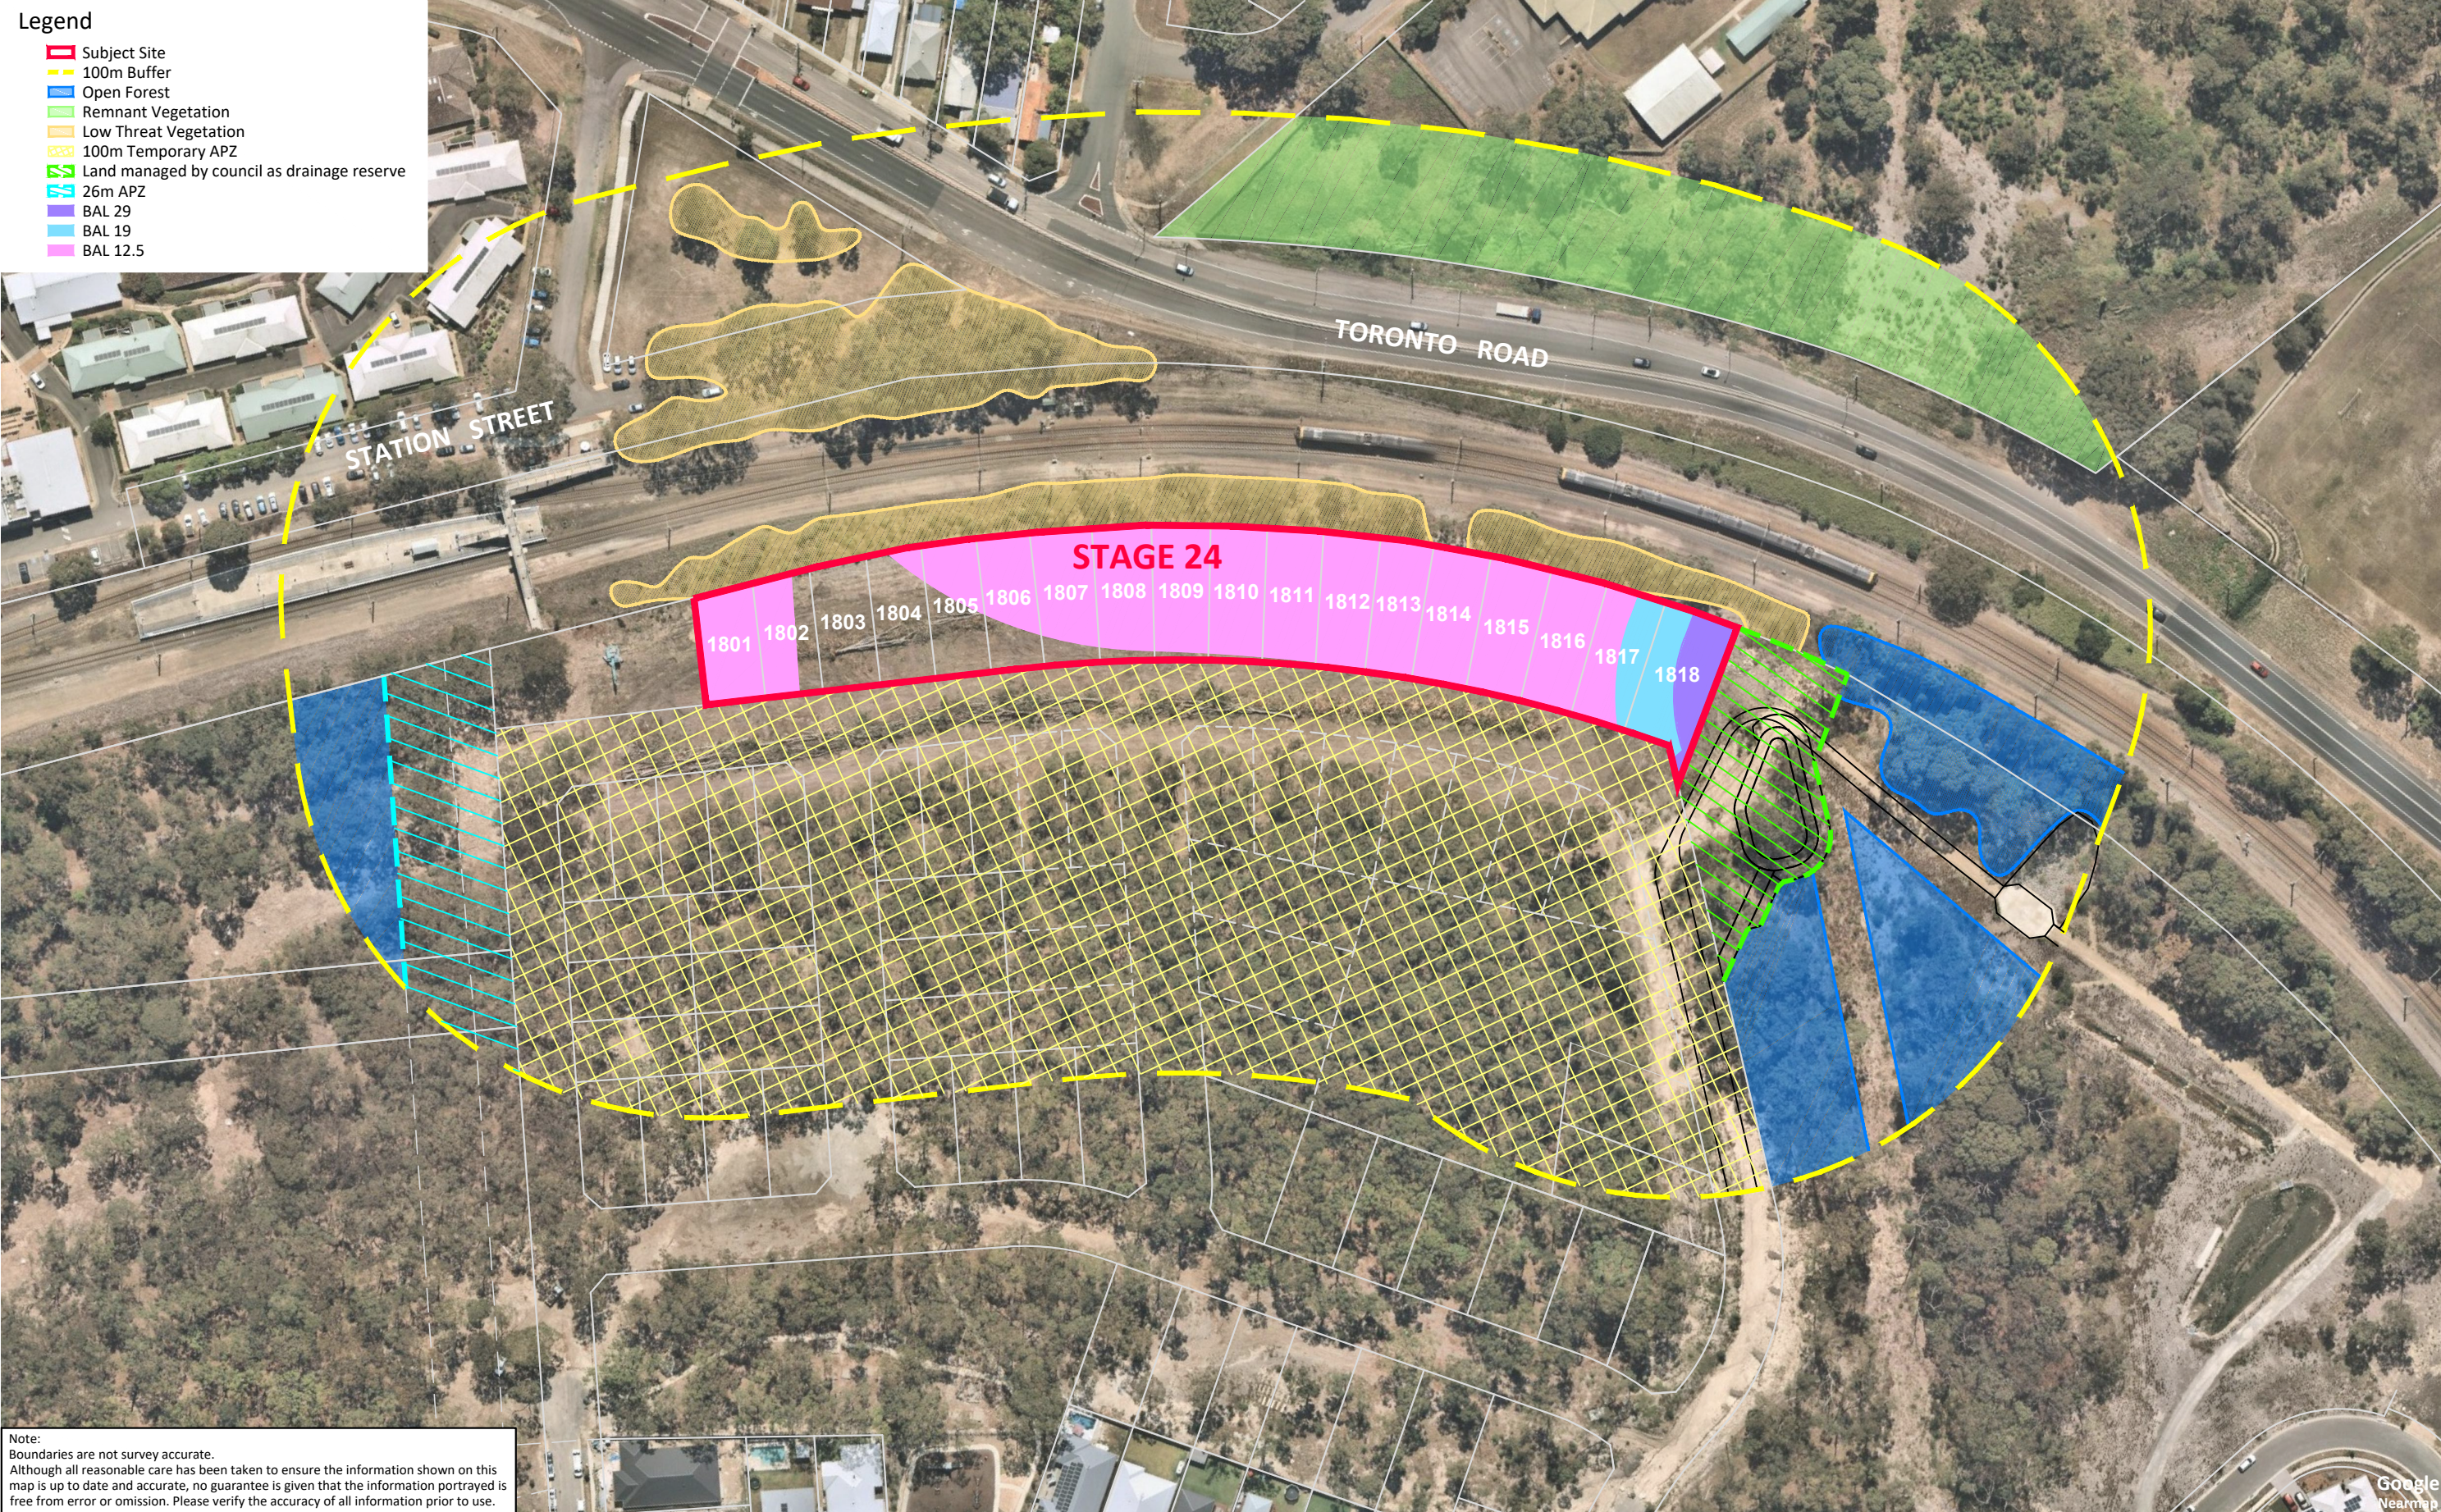
- Legend**
- Subject Site
 - 100m Buffer
 - Open Forest
 - Remnant Vegetation
 - Low Threat Vegetation
 - 100m Temporary APZ
 - Land managed by council as drainage reserve
 - 26m APZ
 - BAL 29
 - BAL 19
 - BAL 12.5

The results from this bush fire attack assessment are detailed below in Table 4-1– Bushfire Attack Level (BAL) Assessment and Figure 4-1 Bushfire Attack Level Map.

This report and mapping are not to be used to place wholesale restrictions on lots reflecting the resulting BAL mapping presented within. Building location and design will influence the application of the required BALs. For example, a lot indicated as being affected by BAL-29 may have those facades that are not exposed to the bushfire threat constructed to a lower BAL (i.e. BAL-19), reducing the costs of construction and providing more flexibility in choice of external building materials. Refer to Appendix B for Summary of AS3959-2018 Construction Standards and Appendix C for Additional Building Requirements.
