BUSHFIRE ATTACK LEVEL

FOR
FUTURE DWELLINGS
AT
STAGE 19
BILLY'S LOOKOUT
TERALBA
NSW 2284

Site Details:	Stage 19, Billy's Lookout, Teralba, NSW 2284					
Prepared by:	Sarah Jones B.Env.Sc.,G.Dip.DBPA (Design in Bushfire Prone Areas)					
	Firebird ecoSultants Pty Ltd					
	A BN – 16 105 985 993					
	PO Box 354, Newcastle NSW 2300					
	M: 0414 465 990 Email: sarah@firebirdeco.com.au					
	T: 02 4910 3939 Fax: 02 4929 2727					
Prepared for:	McCloy Group					
Reference No.	Teralba – Billy's Lookout – McCloy Group					
Document Status & Date:	March 2024

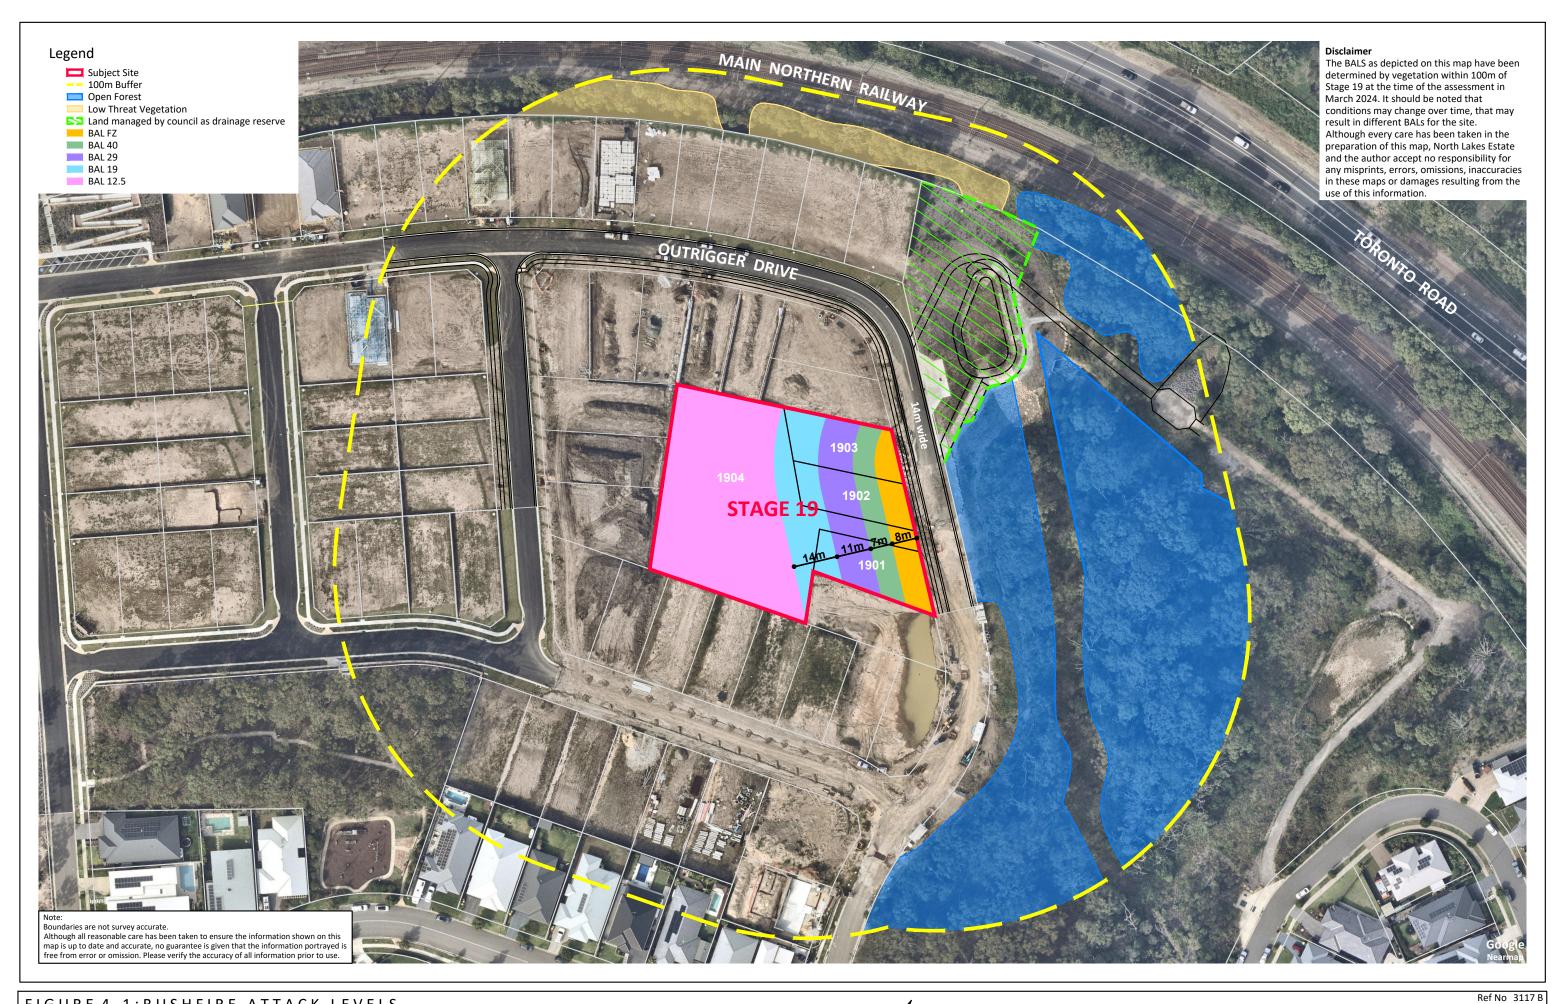
FIGURE 4-1:BUSHFIRE ATTACK LEVELS

The results from this bush fire attack assessment are detailed below in Table 4-1–Bushfire Attack Level (BAL) Assessment and Figure 4-1 Bushfire Attack Level Map.

Lot Number	Vegetation Type within 100m & Direction from future dwellings	Average Slope of Land (degrees)	Separation Distance from Identified Vegetation	Bushfire Attack Level (BAL)	Construction Section
1901	Open Forest to the South	0-5° Downslope	<22mm	BAL-FZ	Sect 3 & 9 of AS3959 and Sect 7.5 of PBP 2019
	Open Forest to the South	0-5° Downslope	22-<29m	BAL-40	Sect 3 & 8 of AS3959 and Sect 7.5 of PBP 2019
	Open Forest to the South	0-5° Downslope	29-<40m	BAL-29	Sect 3 & 7 of AS3959 and Sect 7.5 of PBP 2019
	Open Forest to the South	0-5° Downslope	40-<54m	BAL-19	Sect 3 & 6 of AS3959 and Sect 7.5 of PBP 2019
	Open Forest to the South	0-5° Downslope	54-<100m	BAL-12.5	Sect 3 & 5 of AS3959 and Sect 7.5 of PBP 2019
	Open Forest to the South	0-5° Downslope	>100m	BAL-LOW	No Requirements

This report and mapping are not to be used to place wholesale restrictions on lots reflecting the resulting BAL mapping presented within. Building location and design will influence the application of the required BALs. For example, a lot indicated as being affected by BAL-29 may have those facades that are not exposed to the bushfire threat constructed to a lower BAL (i.e. BAL-19), reducing the costs of construction and providing more flexibility in choice of external building materials. Refer to Appendix B for Summary of AS3959-2018 Construction Standards and Appendix C for Additional Building Requirements.
